# STRESS CORROSION CRACKING— A Caustic Experience

**Here is a closer look at two instances of failure of nickel equipment in caustic environment. A falling-film evaporator developed puncture holes and vertical cracks; a problem of stress corrosion cracking occurred at a flaker drum**

M. P. Sukumaran Nair  
Fertilizers and Chemicals  
Travancore Ltd., India

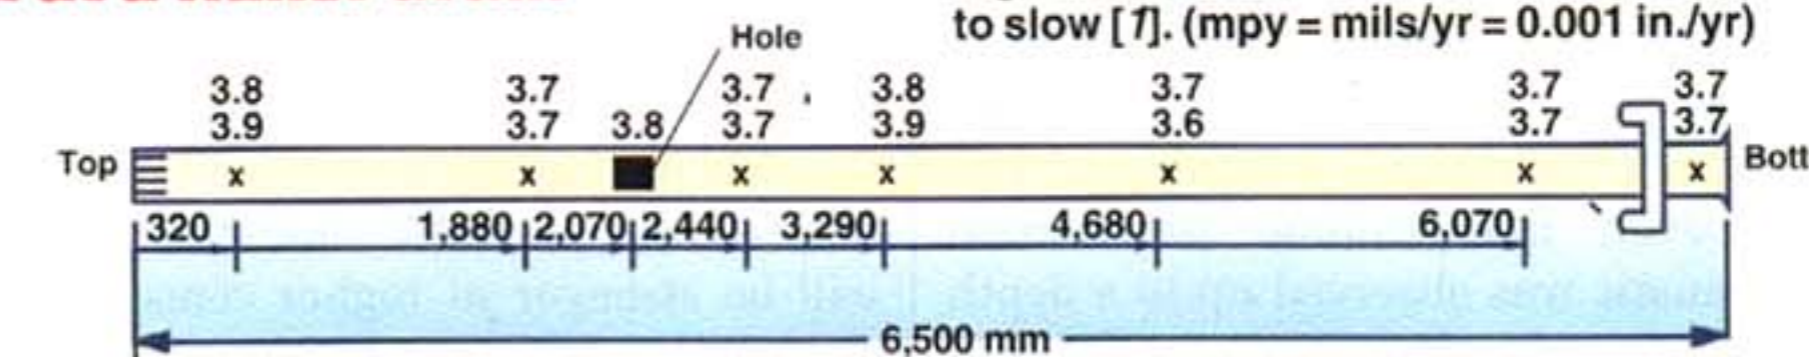
**FIGURE 2.** Most failures in falling-film evaporator tubes occurred between the 4,680 and 6,070 mm marks. On this specific tube, the thicknesses at marked points were all larger than the nominal 3.5 mm, except for the hole at 2,070 mm

We shut down the process, removed the tubes from the jackets, and performed an inspection. The external surfaces were found to be smooth and showed a tinted coloration. There was no sign of any uniform corrosion, and there was only one leak in each of the tubes. The nature of the leaky portion of the tubes varied from small holes to modest-size but wide cracks. Most of the tubes failed in the lower third (Figure 2). In one tube, a 205-mm-long perforation was noticed in the bottom section.

From the above analysis, we concluded that intergranular stress-corrosion cracking, coupled with accelerated corrosion by overheated caustic, might have caused the failure. The presence of stress, caustic soda and high temperature is necessary for such a situation to occur in localized areas.

A possible source of stress is the thermal cycles during startup and shutdown, or process interruptions. Operators must ensure uniform and continuous flow of a thin layer of the liquid along the wall of the tube in a falling film evaporator. If there are any restrictions, the flow will tend to become localized, will stop flowing after some time, and will end as a teardrop.

The abrupt ending of the bottom-most grooves indicated that this had happened. A stationary band of caustic got overheated at the bottom of the tube where the heat transfer salt is at its highest temperature. This led to accelerated and localized corrosion and subsequent failure. We know from other tests that the presence of small amounts of chlorate also accelerates attack on nickel. Unfortunately, chlorates are a characteristic of a membrane-cell chlorine-alkali plant. Figure 4 (which, unfortunately, does not in-

1. Ensure an unbroken film of caustic solution on the inside surface of the tube. Maintain proper distribution of feed, and vertical alignment of tubes.
2. Maintain strict control of chlorates in the feed.
3. As far as possible, take care to see that the tubes are operated without subjecting them to the stress of frequent thermal cycles.

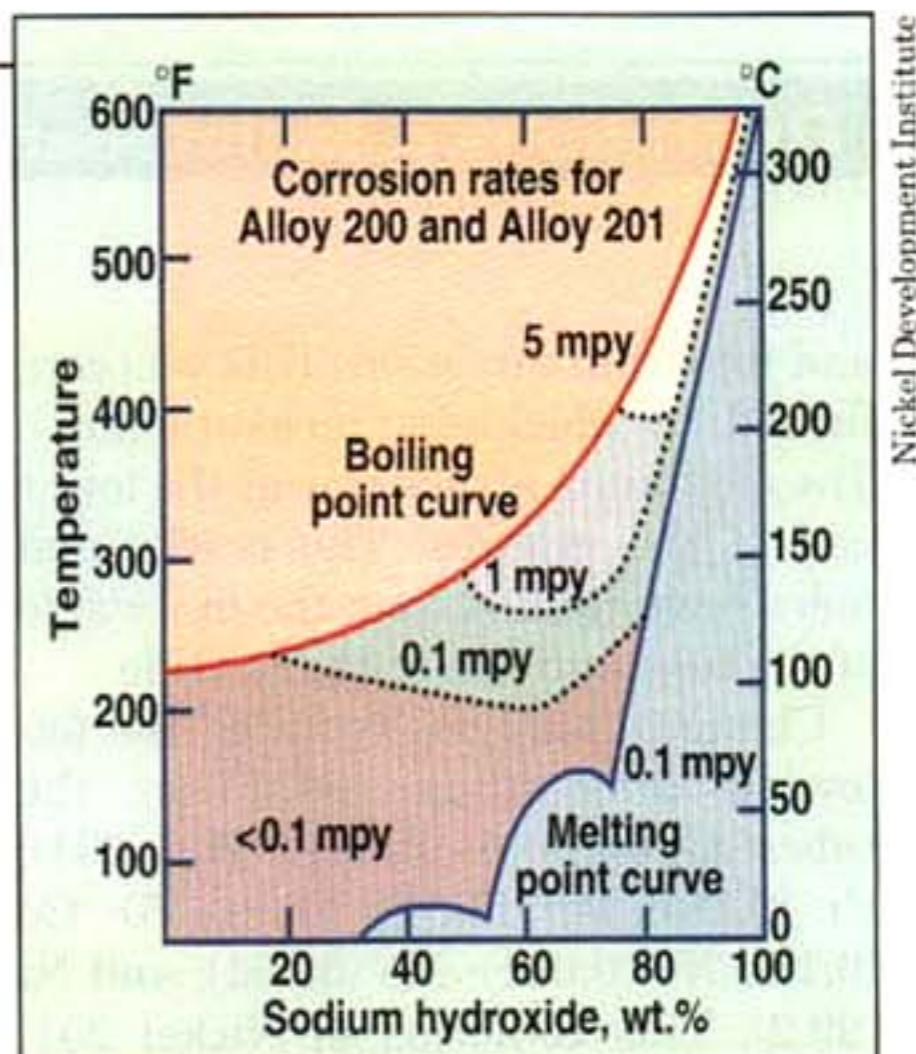
**FIGURE 1.** Hot caustic will corrode Ni 200 and Ni 201. However, at a sufficiently high concentration, corrosion will begin to slow [1]. (mpy = mils/yr = 0.001 in./yr)

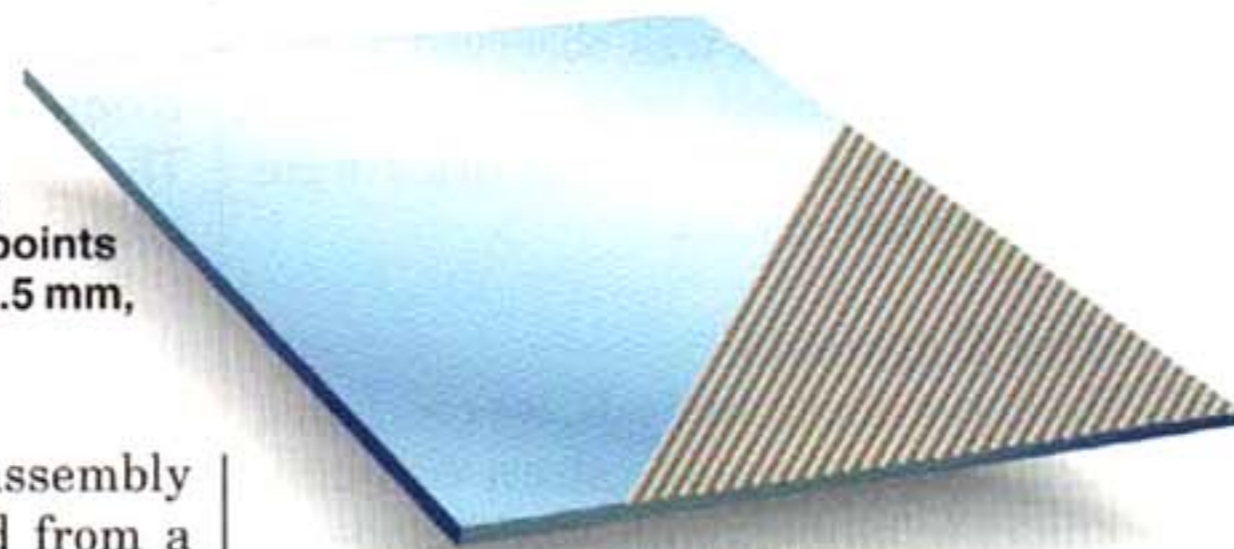
**FIGURE 3.** This illustration shows that corrosion left an area of grooves

The internal surface of the tubes around the failure displayed an attack-pattern of grooves, running from top to bottom. These grooves were about 15 mm wide, and ended abruptly (Figure 3). The remaining tube surface was found to be smooth

and free from corrosion. This was confirmed by thickness measurements. The maximum attack was at the lower end of the grooves. The cracks and holes have started from the inner side of the tube and run to the outside.

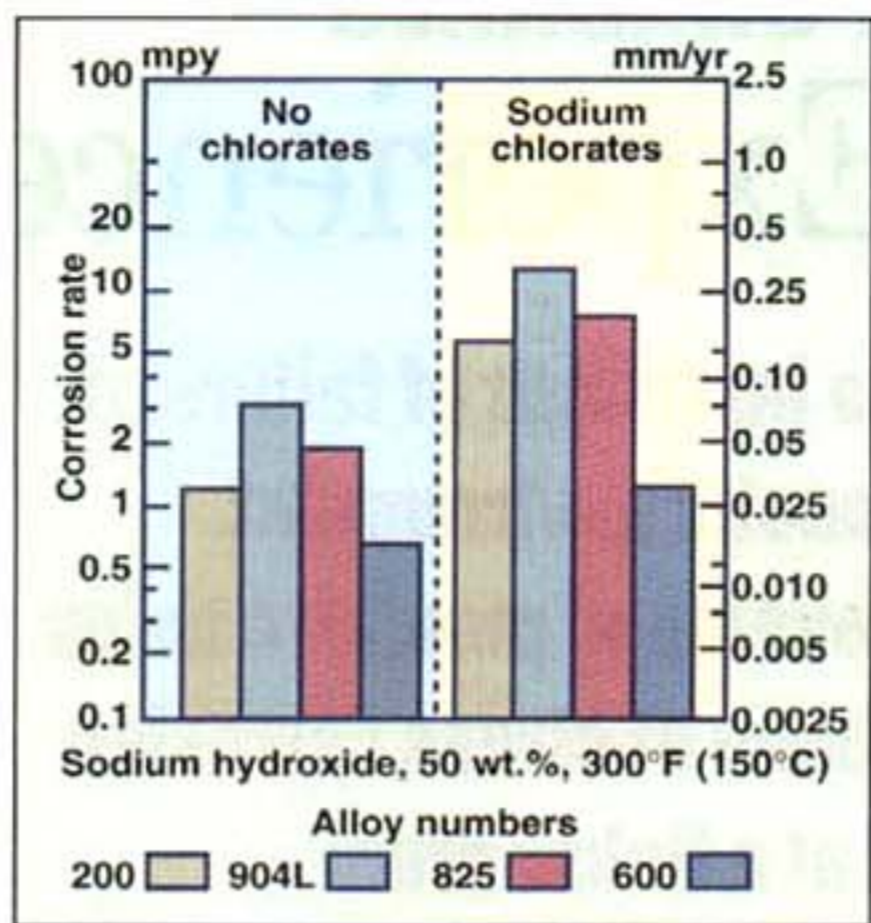
clude data on Nickel 201) shows that a five-fold increase in corrosion occurs in 50% caustic at 150°C, and the effect will be stronger at higher concentrations and temperatures.

**FIGURE 4 (left).** Chlorates in caustic solution caused greater corrosion of four Ni alloys [7].

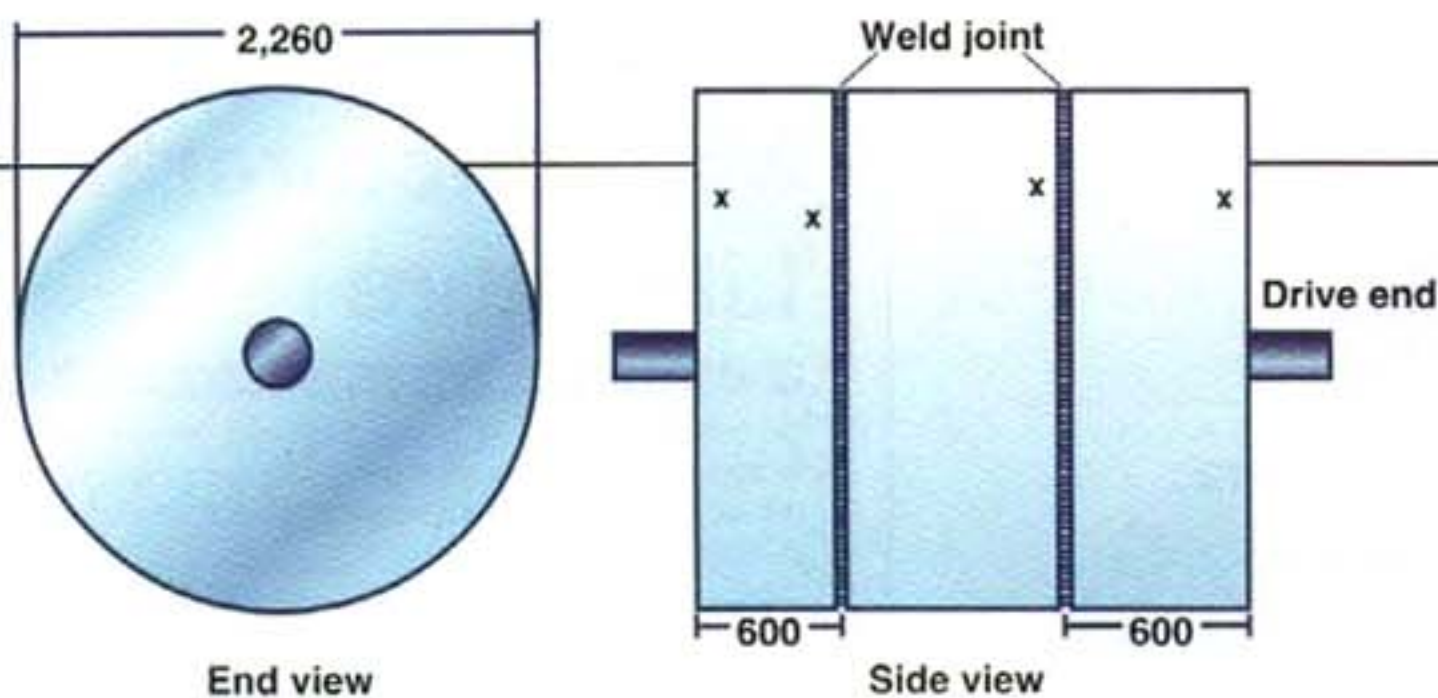
The drum developed a circumferential crack 600-mm long in one of the grooves within six months of commissioning. To arrest further extension of the crack, through-holes were drilled at the end of the grooves, and then the welder cut a 10-mm-deep V-groove. The entire crack was repaired by welding with nickel filler rod.

Two months later the crack extended to the two adjacent grooves and reached a total length of 2,300 mm. The location of the crack was exactly on the outside wall of the internally provided stiffeners. After another welding repair, as above, the plant was returned to service. Shortly, we detected a similar crack, this one in the groove adjacent to the cover plate opposite to the drive end.

The cracks have occurred at the outside wall of the retainer-rings locations. Considering the short span of six months in service during which these cracks appeared, it is evident that these are not perforating cracks due to corrosion. A corrosion rate of 100 to 200 mm/yr for nickel in fused caustic is required to develop such cracks.

A logical interpretation is that the cracks originated from the internal surface and then propagated outward. This is why the later cracks could not be detected by dye-penetrant checks. As the internal fluid is deaerated

**FIGURE 5.** Failure occurred in the grooves of the flaker drum. The thickness at four marked points was nominally at the specified 15 mm (dimensions above are in mm)

The only plausible mechanism left is related to stress. We concluded that the presence of leftover stress after metalworking and fabrication, due to inadequate stress relief, initiated the cracking process. The wide temperature difference between the inner and outer surface of the drum wall, and the cyclic heating and cooling, produced thermal stresses. In addition, the side plates and the stiffeners put a bending restraint on the drum wall.

Under such a situation, the cold face will be under tension and the hot one will be under compression. The stress level may not be sufficient to initiate any cracks in the plate, but the weld-points of the stiffener rings and the

end plates could act as stress raisers. Under changing stress levels, due to cyclic heating and cooling, the equipment can end up cracking from thermal fatigue. The residual stress after weld repairs of the cracks also added to the overall stress level. Subsequent development of cracks near the side-plate joint reinforces this argument.

On prolonged heating above 315°C, carbon precipitates at grain boundaries as graphite and embrittles the metal. Under the influence of stress,

grain boundary cracking occurs. Nickel 201 would have been a better choice in this case. Following the investigation, the plant replaced the flaker drum with one made of Nickel 201. ■
