# Failure analysis of a primary reformer riser

Investigation revealed the root cause was creep rupture

A. AL-MESHARI, A. BABAKR and M. AL-RABIE, Saudi Basic Industries Corp., Jubail, Saudi Arabia

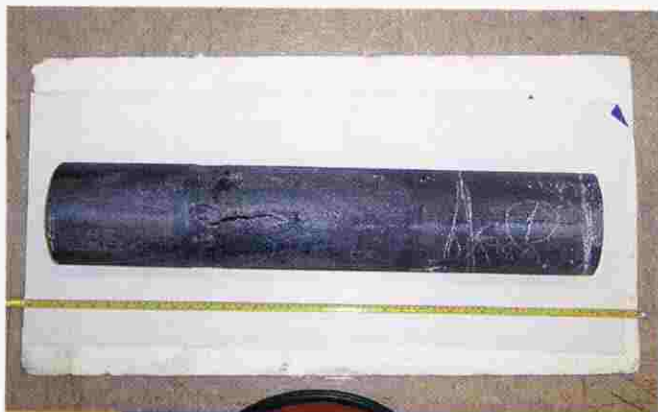
FIG. 1. A longitudinal crack developed in riser A.

Visual inspection of the riser A sample revealed that a crack developed longitudinally (Fig. 1). Part of the crack was through the weld while the rest was through the base metal. Secondary cracks associated with the main crack were observed as well (Fig. 2). Some plastic deformation in the form of bulging had been noticed, especially in regions around cracks. The material was nonmagnetic.

- All risers must be immediately replaced with new material of the same type as the original one. The existing material cannot be guaranteed to handle process loads as it ages.
- Catalyst tube replacement should be considered with risers replacement.
- The reformer owner should have conducted a thorough tube life assessment immediately after they passed their design life (i.e., 100,000 hr).

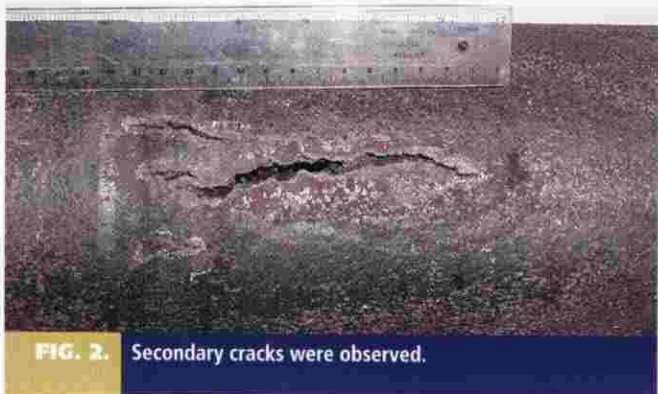
FIG. 2. Secondary cracks were observed.

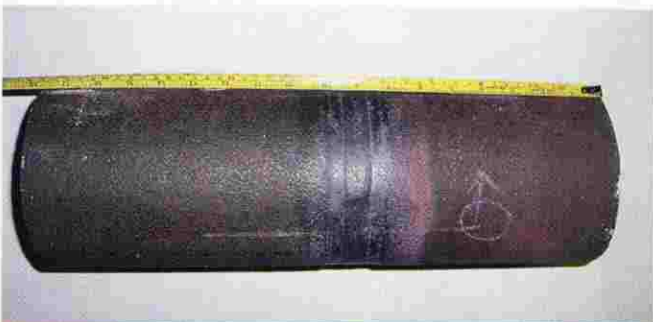
FIG. 3. No cracks were observed in riser B.

As Fig. 3 shows, no signs of cracks or bulging were observed on the riser B sample. The weld seemed intact and in sound condition, yet the material was not magnetic. Not much wall loss had been observed in both samples.

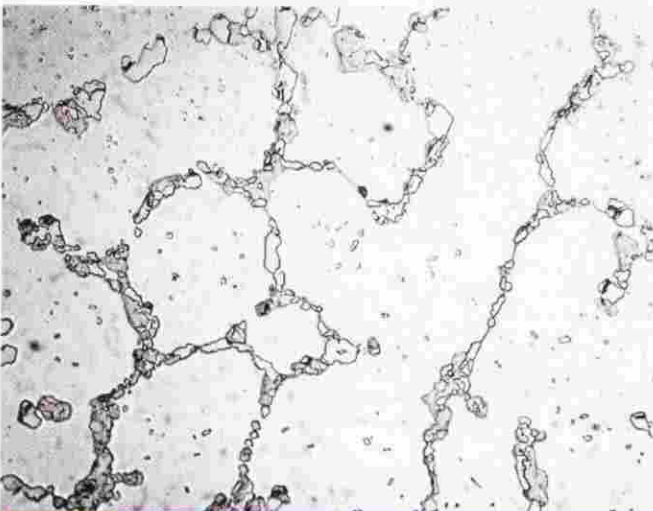
FIG. 4. Austenitic microstructure with carbides precipitating at grain boundaries within matrix (400X, etched).

Optical microscopy revealed austenite microstructure with carbides, coalesced and coarsened, precipitating at grain boundaries. Additionally, secondary carbides were observed within matrices (Figs. 4 and 5). Fig. 6 discloses the nature of the crack. This photomicrograph confirms that the crack was caused by creep rupture. Almost all sample microstructures had microvoids and stress ruptures in different stages (Figs. 7–10). Some microvoids had oriented and linked up, constituting internal and external cracks.

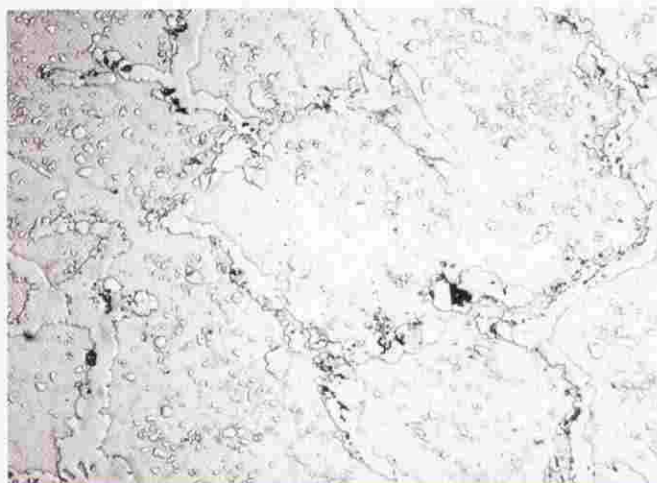
**FIG. 5.** Carbides coarsened and coalesced at grain boundaries. High concentration of secondary carbides precipitate inside the dendrites (400X, etched).

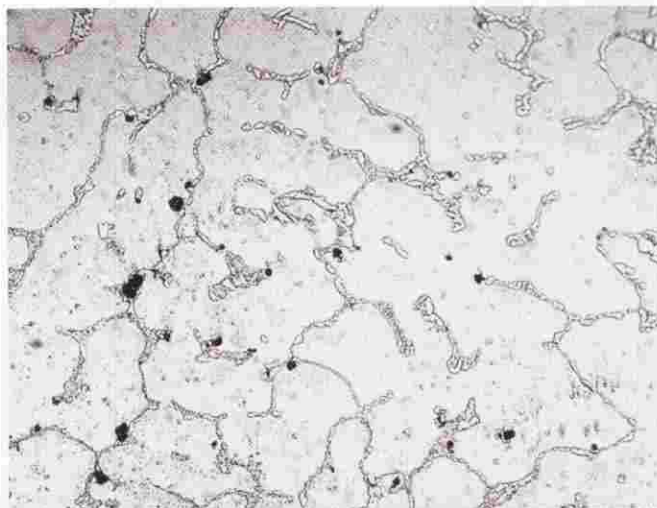
**FIG. 7.** Creep microvoids could be seen through the microstructure (200X, etched).

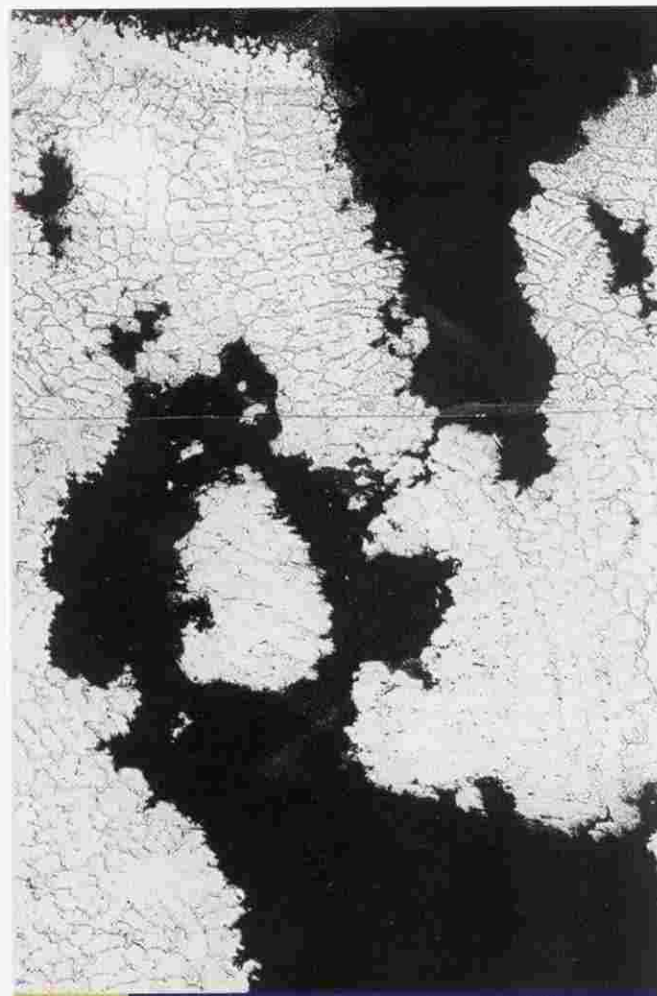
**FIG. 6.** Micrograph of one of the crack tips revealed the cause was creep rupture.

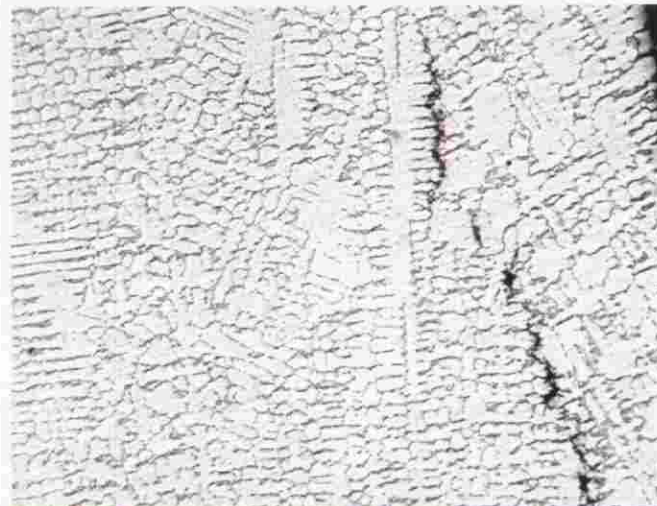
**FIG. 8.** Creep internal cracks were observed in some samples (50X, unetched).

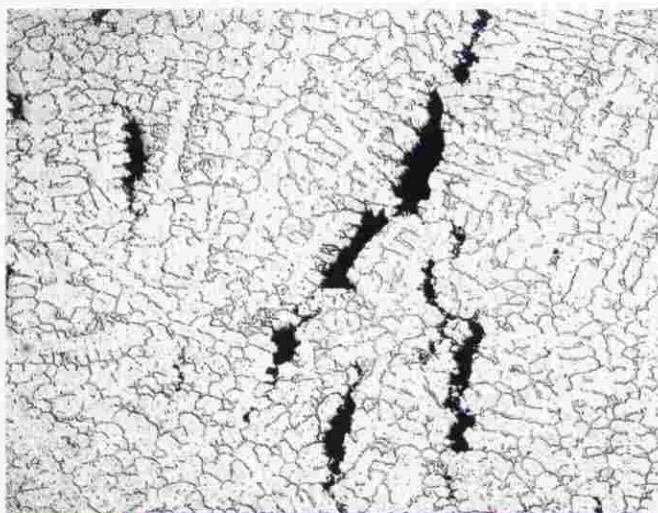
**FIG. 9.** Minor creep ruptures were noticed within the material of both risers (50X, unetched).

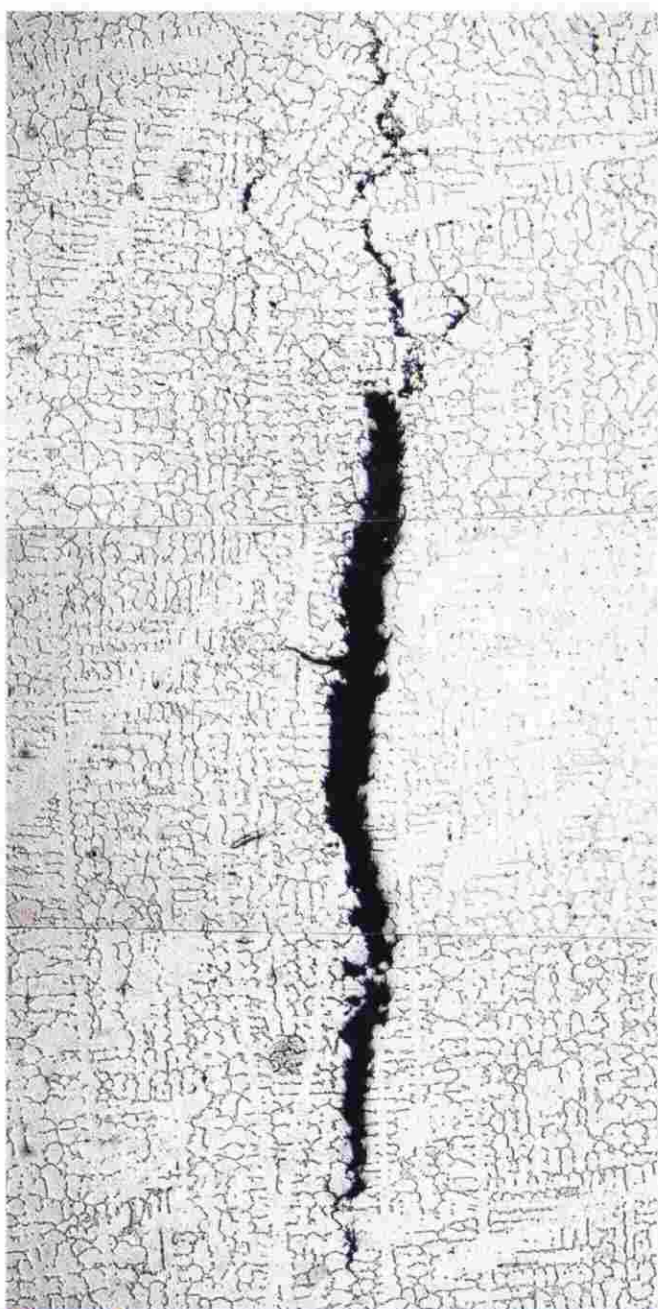
**FIG. 10.** A crack developed through the riser wall. Creep voids linked up and oriented to form such a crack (50X, unetched).

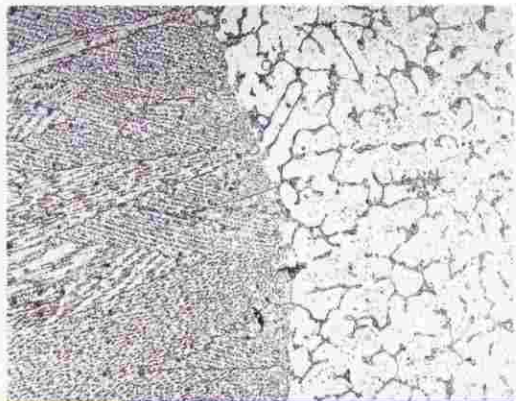
As for riser B welding, which visually looked sound, a high concentration of microvoids was found. The weld microstructure was austenitic-rich with carbides (Figs. 11 and 12).

**FIG. 11.** Carbides-rich austenitic weld microstructure (100X, etched).

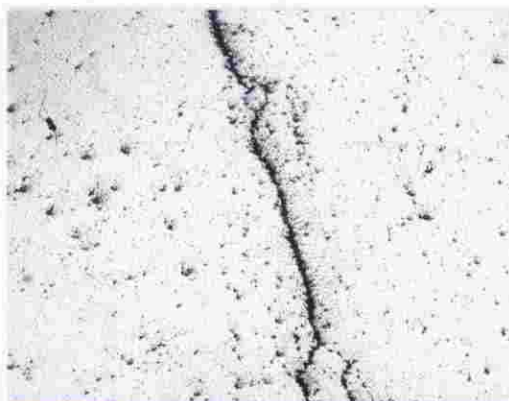
**FIG. 12.** Creep voids and cracking were observed in the weld (50X, unetched).

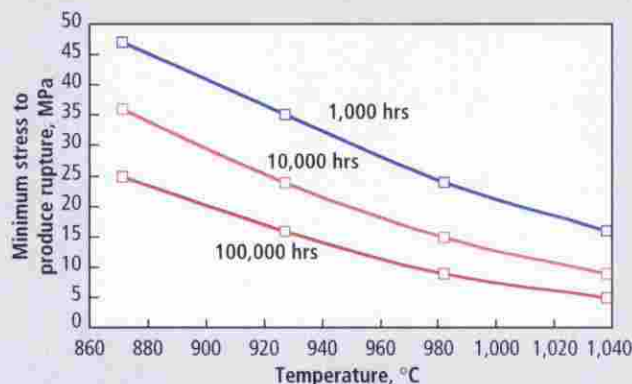
As indicated from the material data sheet, design life of risers is 100,000 hr (about 11.5 yr). However, the risers had been in service for about 140,000 hr (16 yr). Fig. 13 illustrates the influence of time as well as temperature on the minimum stress value needed to produce rupture. Obviously, as temperature, exposure time or both increase, minimum stress to produce rupture decreases. For instance, after 1,000 hr of exposure to 870°C service, minimum stress to produce rupture is about 47 MPa.

However, at the same temperature and after 100,000 hr of exposure, minimum stress to produce rupture is about 25 MPa. So as exposure time approaches 140,000 hr, minimum stress to

**FIG. 13.** Both time and temperature influence the minimum stress value to produce rupture.

produce rupture is expected to be considerably below 25 MPa and whether the material can still withstand process loads is in doubt. It should be emphasized that these data are obtained from controlled ideal laboratory experiments. However, it is very difficult to determine the exact design life of reformer furnace tubes.
