Repair critical-service exchangers with innovative methods

In this case history, unconventional maintenance techniques stopped chronic leaking for an olefin's heat-exchanger circuit

R. RAJKUMAR, Reliance Industries Ltd., Surat, India

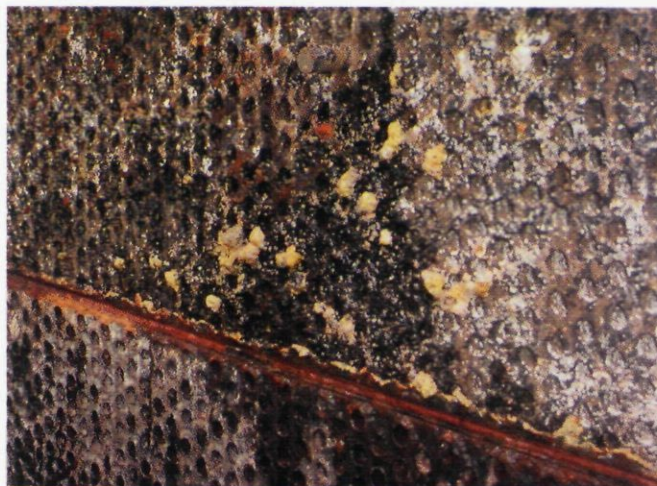
FIG. 1 Inspection of the propylene exchanger shows deposits on the tube sheet after service.

- Blackish/brownish colored deposits (4 to 5 mm thick) observed at both (east and west side) tube sheets.

- Nugget-type deposit was found at dish-end internal surface, at a few locations. With cleaning, a brownish scale with under-deposit corrosion effects was observed (Figs. 1 and 2).

To avoid low-velocity, under-deposit corrosion, cooling water flow for this exchanger was increased. However, the cooling water flowrate was observed as 0.7m/s as against the required minimum flowrate of 1m/s. To increase the cooling water flowrate to 1m/s, the cooling water network had to be modified; unfortunately, this action was not viable.

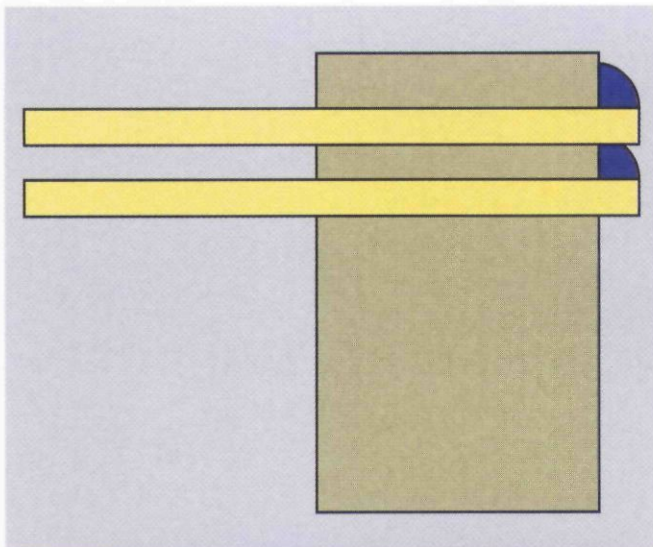
FIG. 2 Location of the deposits on tube sheet.

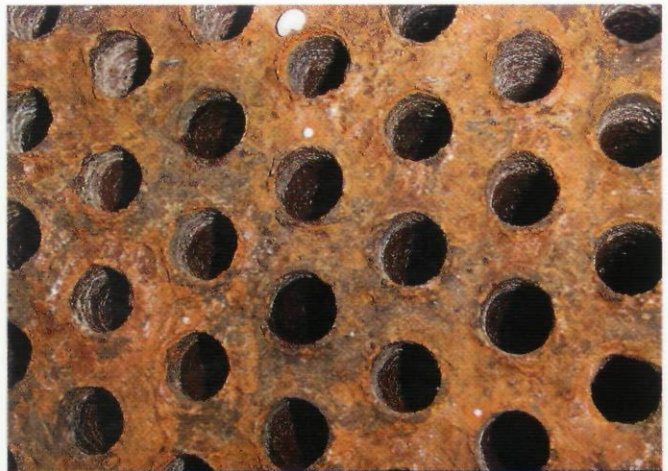
FIG. 3 View of the TTSJ before the repair.

- The existing damaged tube edges and TTSJ fillet weld were completely removed/flushed-off by using cutting/facing tool.

- Further grooving around 2–3mm deep was made in tube sheet, adjacent to tubes OD to facilitate fillet welding of TTSJs. Proper tool/fixture arrangements were made to avoid further damage of tube edges/ligaments.

- All TTSJs were welded under strict quality adherence checks (Figs. 3 and 4).

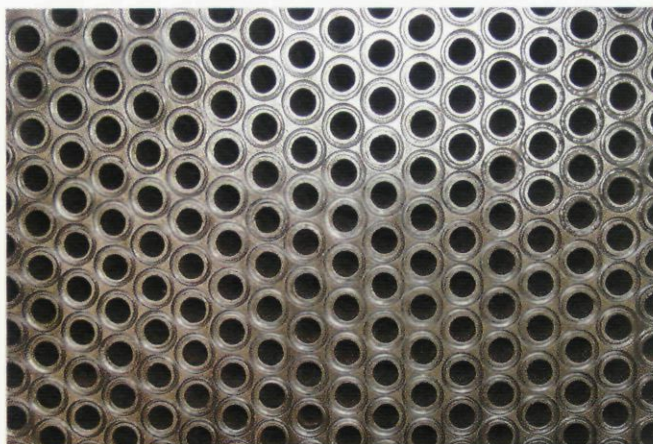
FIG. 4 View of the TTSJ after the repair.

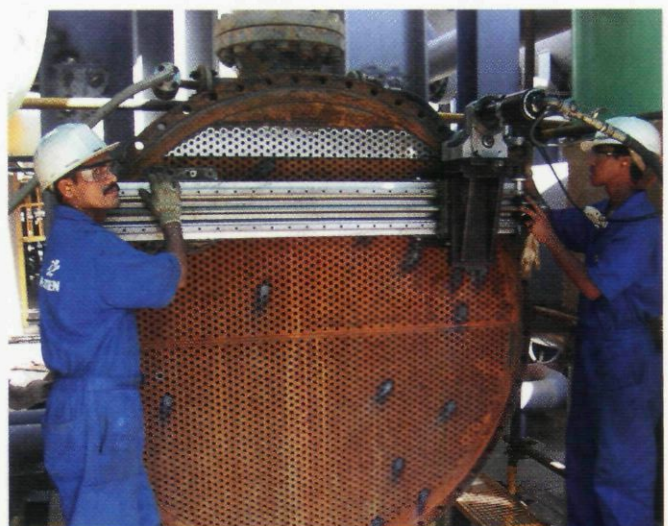
FIG. 5 In situ machining of the exchanger TTSJs.

In situ machining of tube sheet. Normally, in situ machining is done only on the gasket-seating area of a tube sheet. In this case, it was necessary to machine the entire surface of the tube sheet with high accuracy. A special purpose machine was used for tube-sheet face machining. Required surface finish and flatness as per standard was achieved with this method (Figs. 5 and 6).

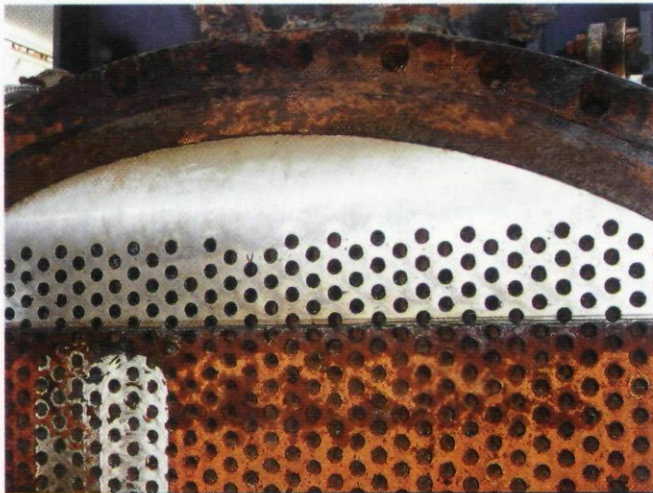
FIG. 6 View of the finished in situ machined to the tube sheet surface.

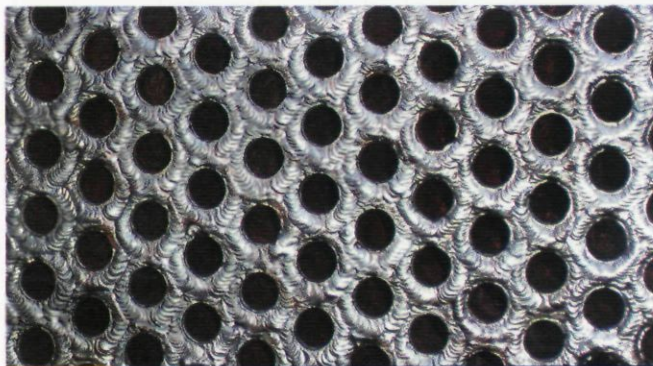
FIG. 7 View of the root weld and finish welds of the tube sheet.

Welding of TTSJ. Tube to tube sheet welding was done by argon welding technique. All the necessary nondestructive testing (NDT) checks were done during the process (Fig. 7).

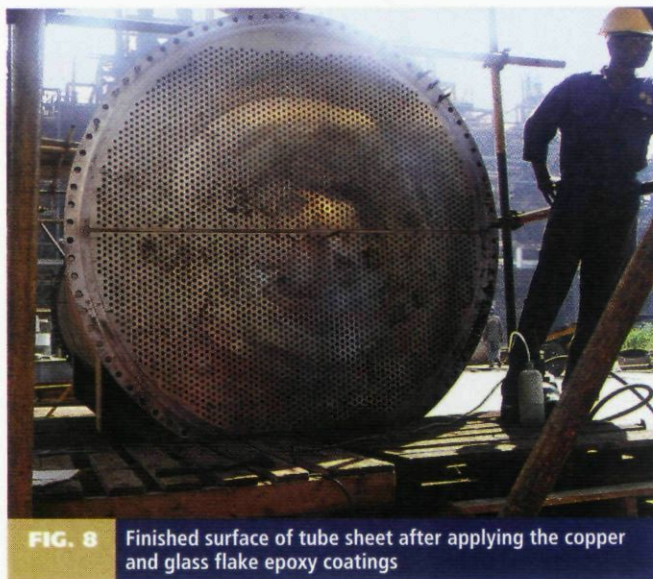
FIG. 8 Finished surface of tube sheet after applying the copper and glass flake epoxy coatings

Coating on tube sheet. First, copper-flake blasting was applied. Later, a glass-flake epoxy coating was applied with a minimum thickness of 600 μ (Fig. 8).
