Failure analysis of an ethylene cracking heater finned tube

Here's what caused the leak and the steps taken to prevent future leaks

R. P. GUPTA and P. MOON, IPCL, Nagothane, India

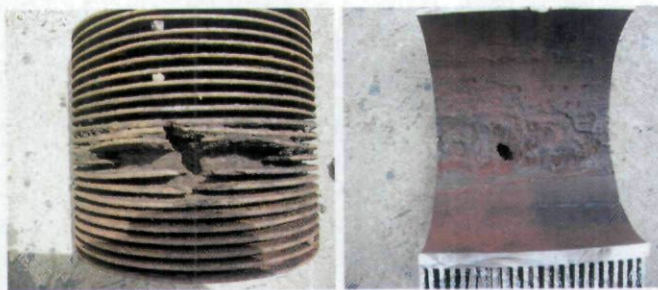
Appearance/morphology of damage. An elliptical shaped 12-mm × 7-mm puncture was noticed toward the north side of the convection zone at the tube entry point in the convection zone.

Erosion and erosion corrosion are characterized by a localized loss in thickness in the form of pits, grooves, gullies, waves, rounded holes and valleys. This loss often exhibits a directional pattern (Fig. 1).

FIG. 1 Erosion and erosion corrosion are characterized by a localized loss in thickness.

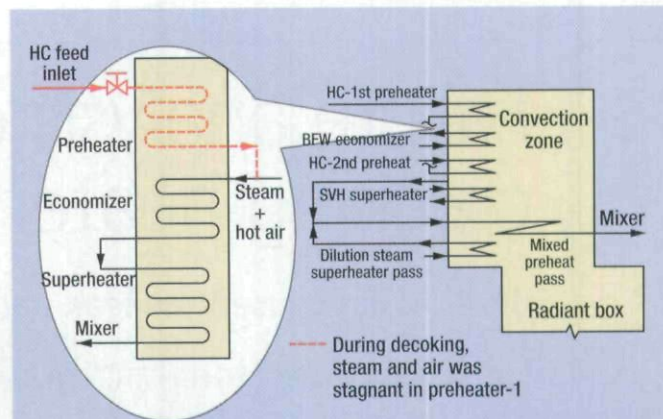
Hydrocarbon preheater-1's function is to preheat the HC (i.e., ethane/propane) from 65°C to 125°C to 145°C through furnace flue gases. Preheater-1 contains HC with DMDS catalyst in normal furnace cracking operation. During the decoking cycle, the HC feed control valve remains closed whereas decoking steam and hot air are introduced through preheater-2. From preheater-2 onward, steam is live, i.e., circulating through preheater-2, the economizer, the superheater and furnace area, and the decoking network piping including the decoking pot. The only area where the steam is not live, i.e., the steam is stagnant, is preheater-

1 (Fig. 2). The operating data are shown in Table 1.

FIG. 2 The only area where the steam is not live is in preheater-1.

- Stagnation of steam and condensate during the heater decoking cycle is avoided by providing a line from the HC control valve low drain point to the decoke pot so that during furnace decoking, positive flow through hydrocarbon preheater 1 can be ensured.

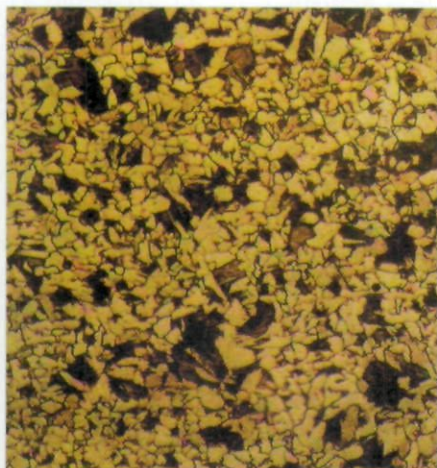
The microstructure of the failed finned tube cross section was examined and found to be normal, i.e., ferrite and pearlite (Fig. 3). Approximate grain size was 7–8, meaning a fine-grained CS microstructure is normal for CS-A 106 Gr. B.

FIG. 3 The microstructure of the failed finned tube cross-section was examined and found to be normal.

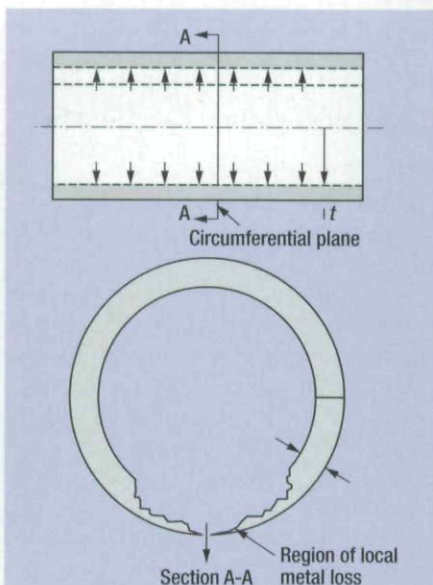
- Severe roughening and pitting were noticed at the 6 o'clock position on the internal surface of the tube near the puncture area, which may be indicative of the presence of moisture from steam condensate, O₂, sulfur (40–50 ppm) from DMDS, CO₂ from HC, and NH₃ from hydrazine, i.e., a corrosive environment.

Stagnant steam and condensate during the heater decoking cycle increased the corrosivity of the environment and led to failure of the HC preheat line finned tube in the convection zone (Fig. 4).

FIG. 4 Local metal loss was evident in the internal bottom portion of the tube.

- A tube of the other heater similar to preheater-1 should be removed for the inspection to assess its health.
