# World Housing Encyclopedia Report

Country: Colombia

Housing Type: Gravity concrete frame buildings (predating seismic codes).

Report Number: 11

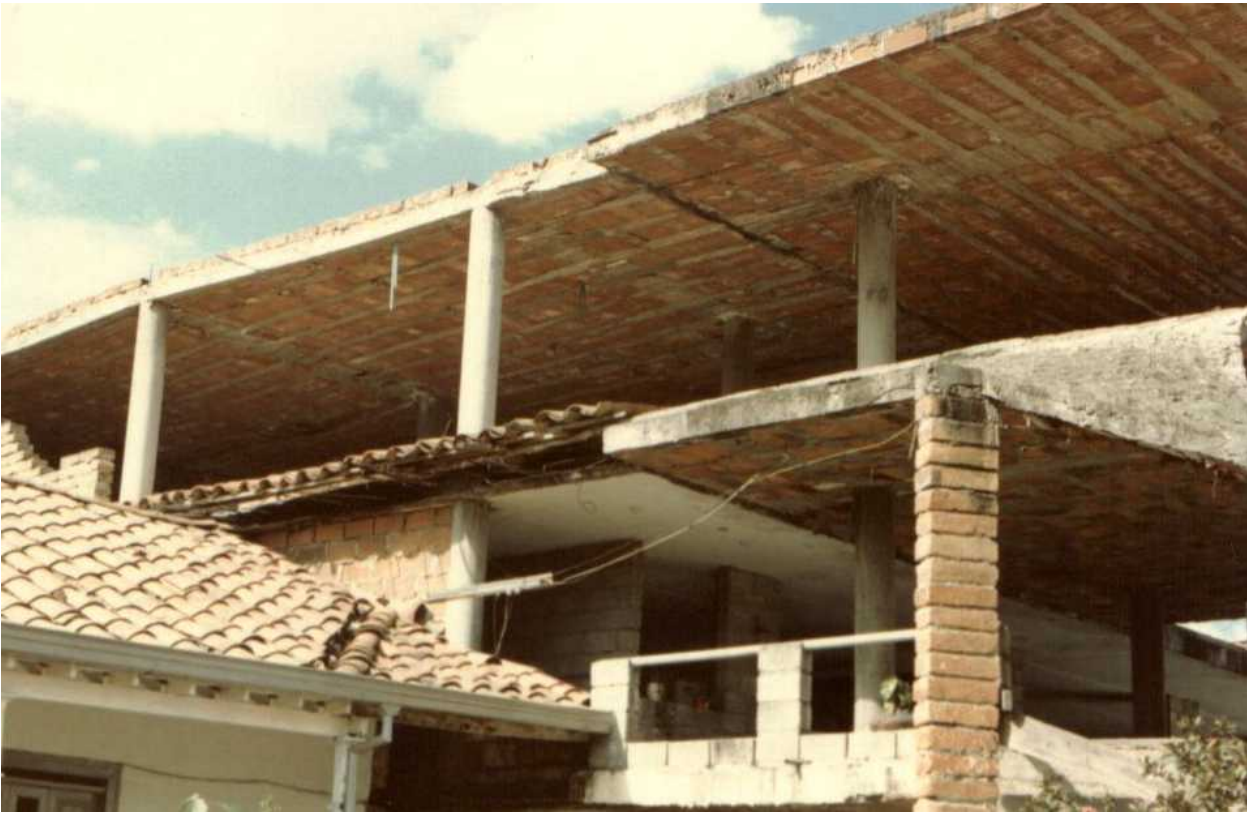
*FIGURE 1: Typical Building*

This is typical multi-family housing construction found in urban areas of Colombia that predates seismic codes. This housing type is widely used and represents 60% of the existing housing stock. At the present time, poor people occupy buildings of this type. This construction is rather vulnerable to seismic effects due to a limited amount of transverse reinforcement (ties); this is especially true for columns. This structural system is very flexible when subjected to lateral seismic loads. The quality of materials and workmanship is typically rather poor. In many cases, buildings of this type are constructed on a very steep terrain; soil condition is often rather poor.

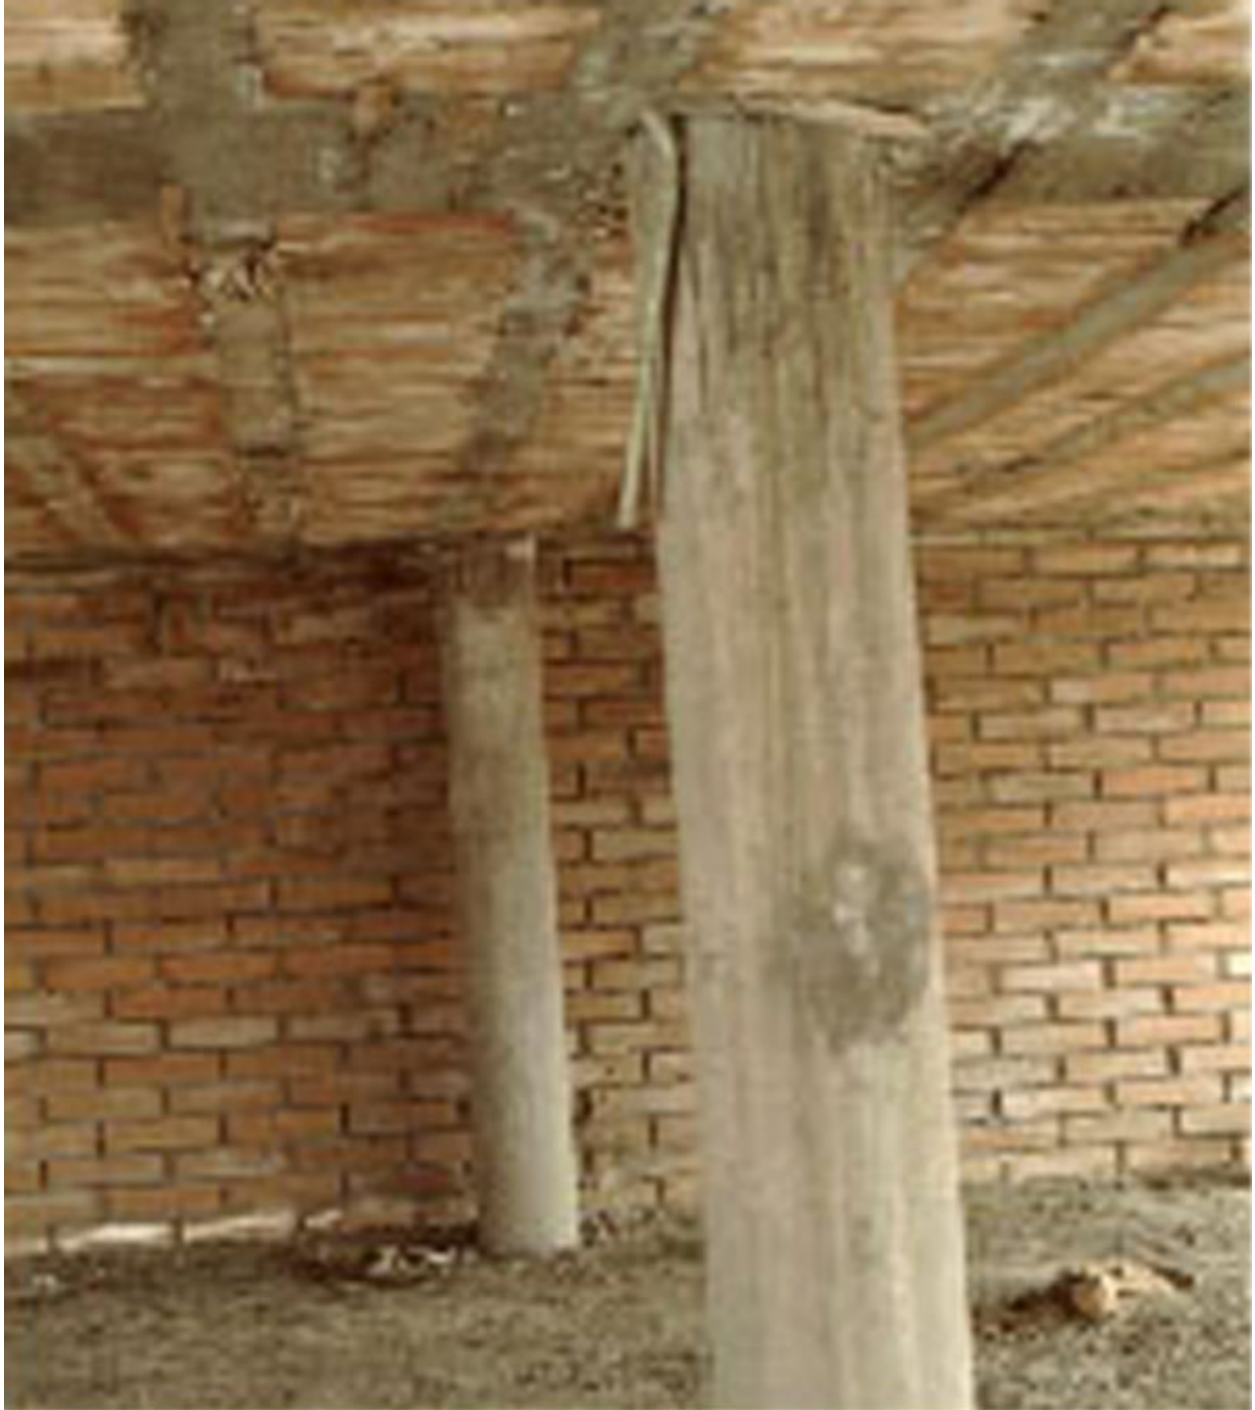
*FIGURE 5A: Poor Construction Practice: Beams constructed in one direction only*

Additional Comments: Typical seismic deficiencies related to this type of construction, mainly due to poor construction practices and workmanship, are illustrated in the FIGURES 5A, 5B, 5C, 5D and 5E.

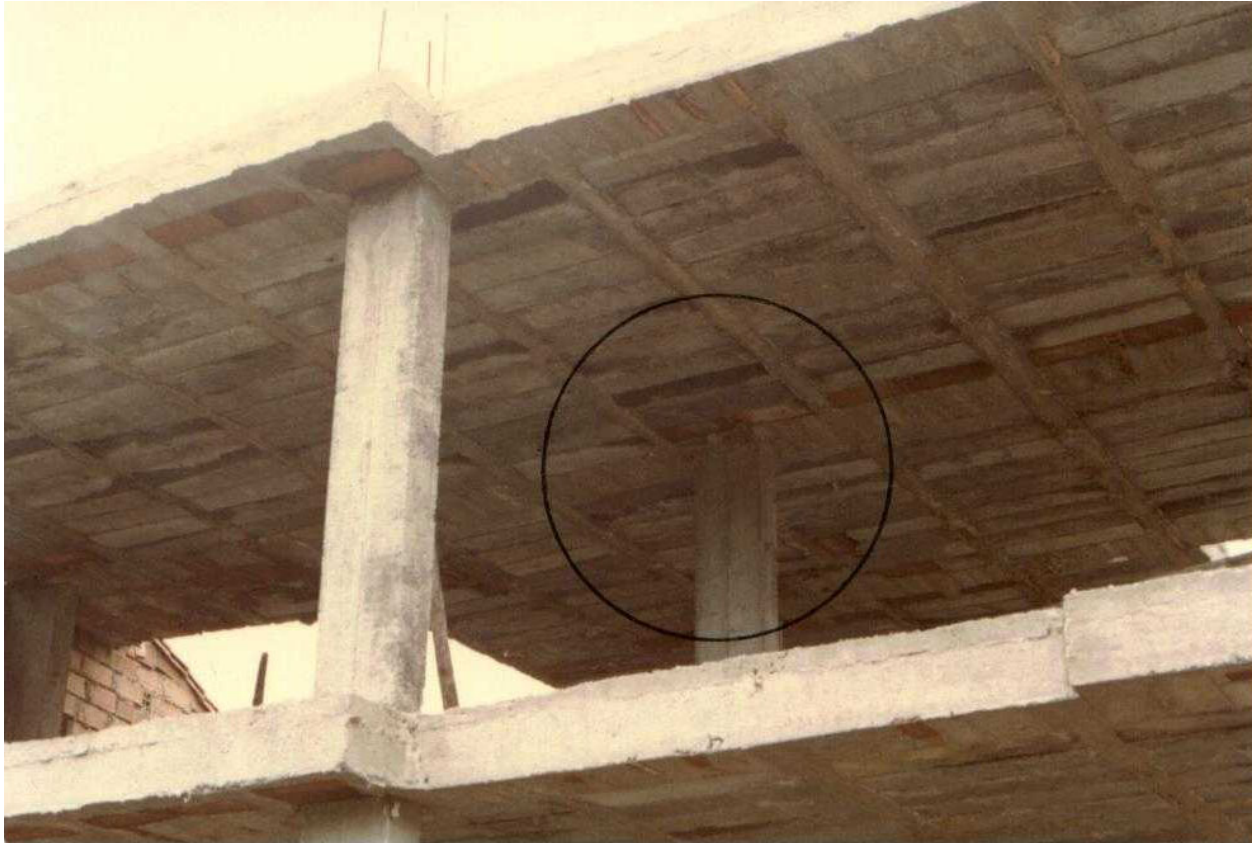
*FIGURE 5B: Poor Construction Practice: Beams constructed in one direction only*

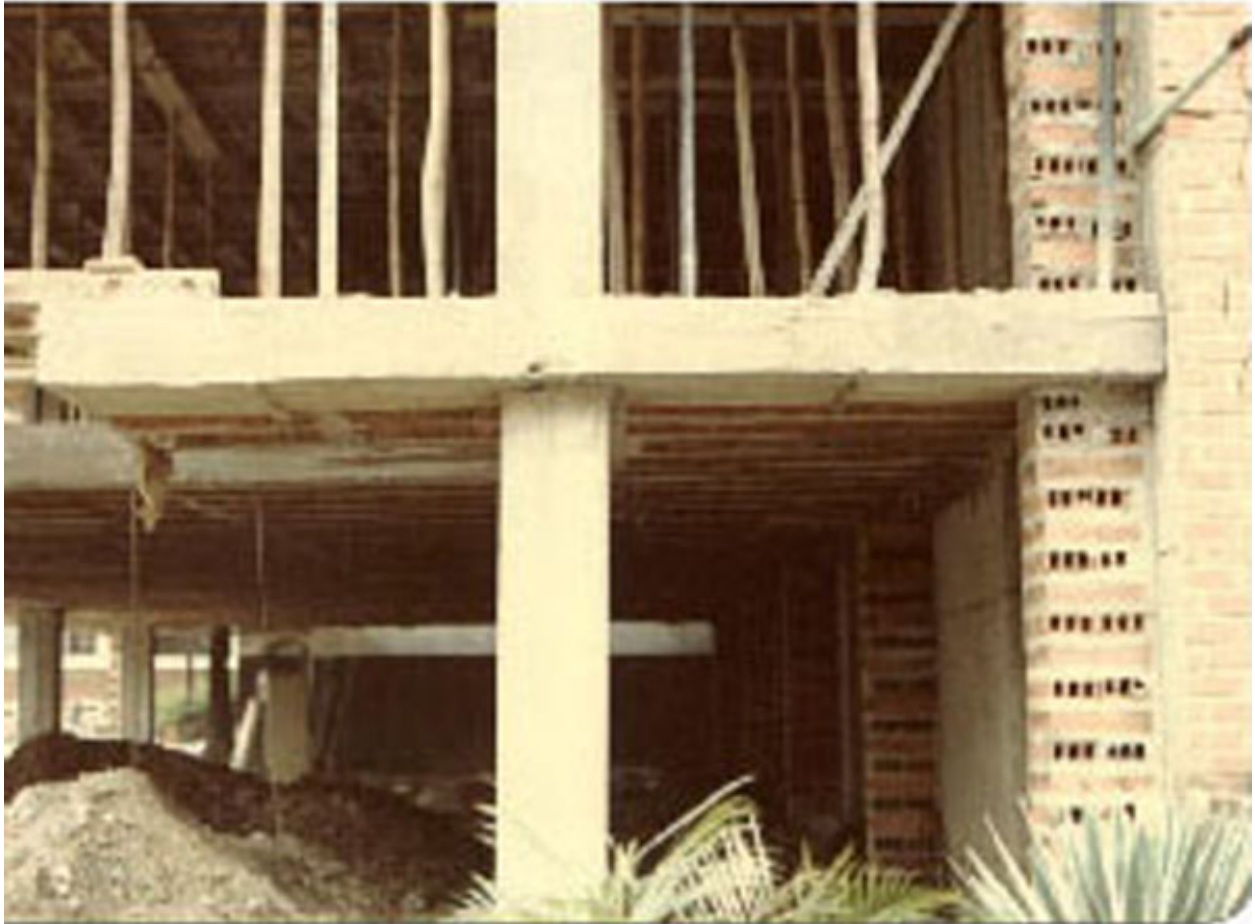
*FIGURE 5D: Poor Design: Combination of Concrete Frames and Unreinforced Masonry Walls or Pilasters*

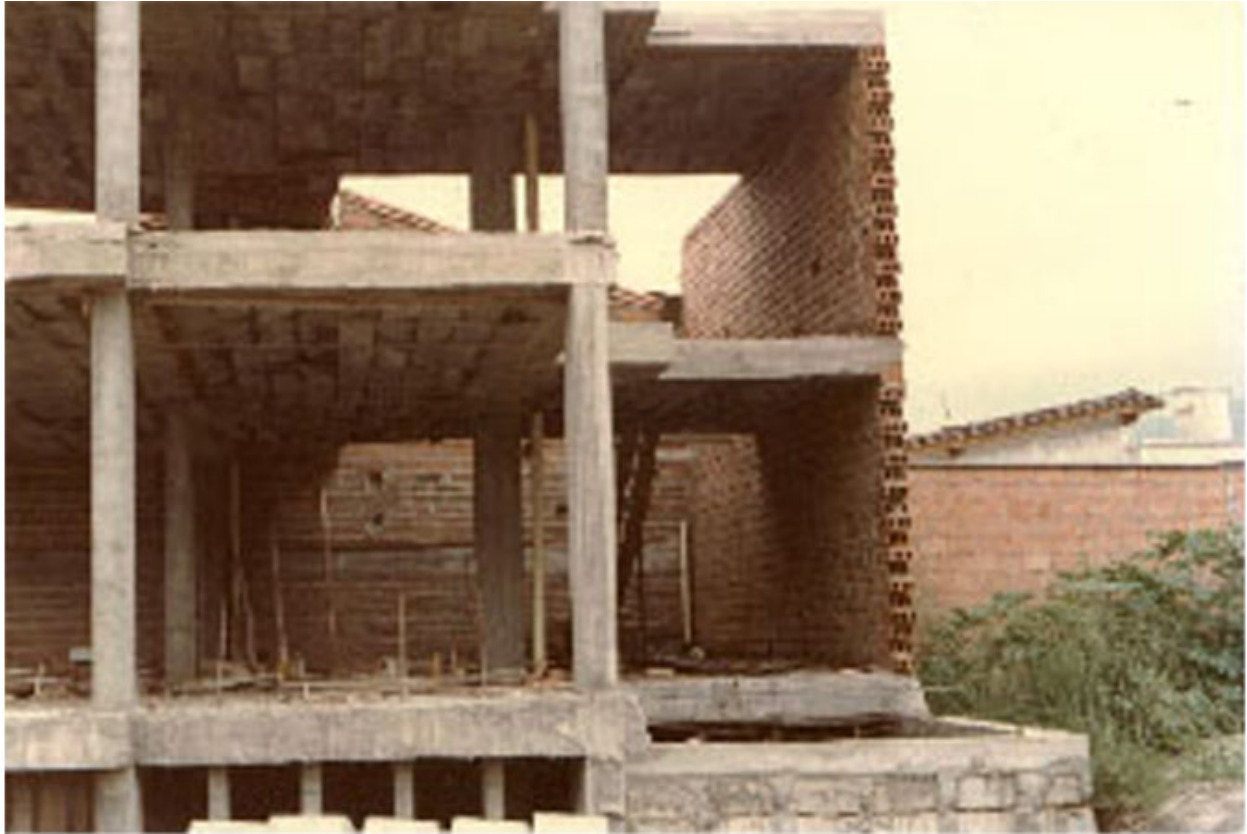
*FIGURE 5E: Poor Design: Combination of Concrete Frames and Unreinforced Masonry Walls or Pilasters*

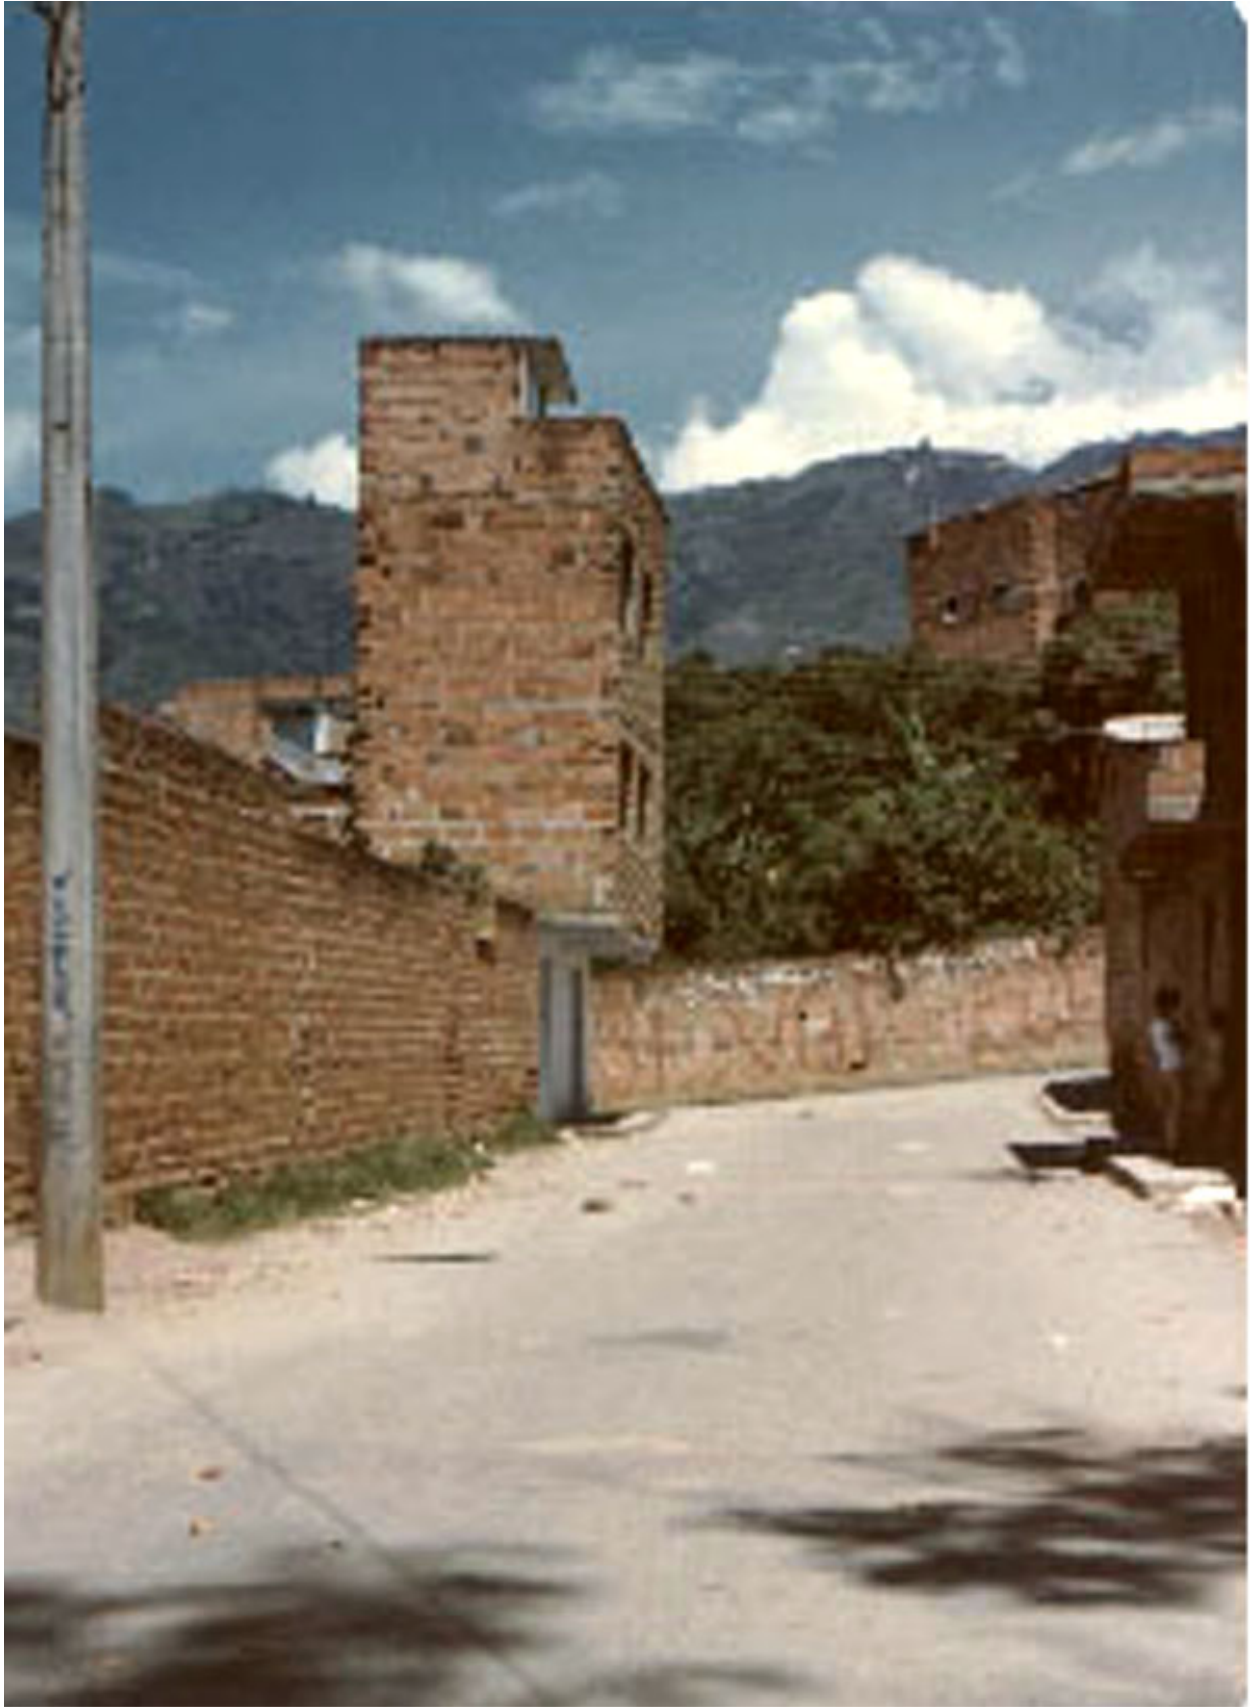
*FIGURE 5F: Playing with the laws of equilibrium*

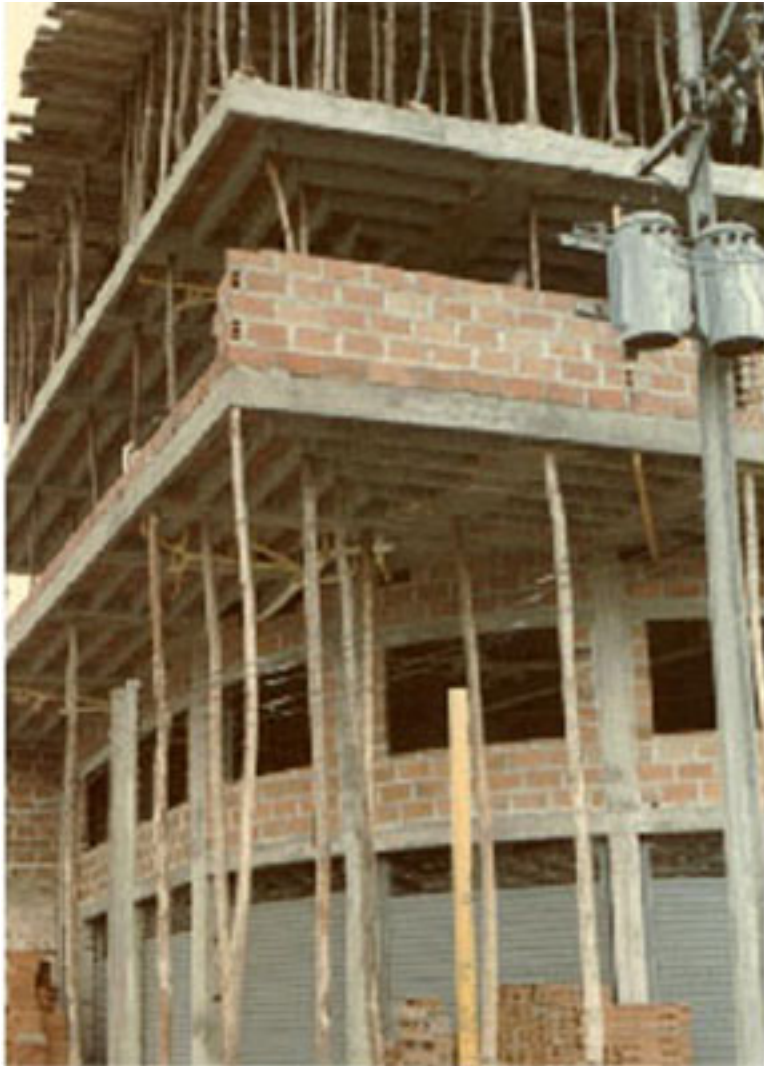
*FIGURE 5G: Playing with the laws of equilibrium*

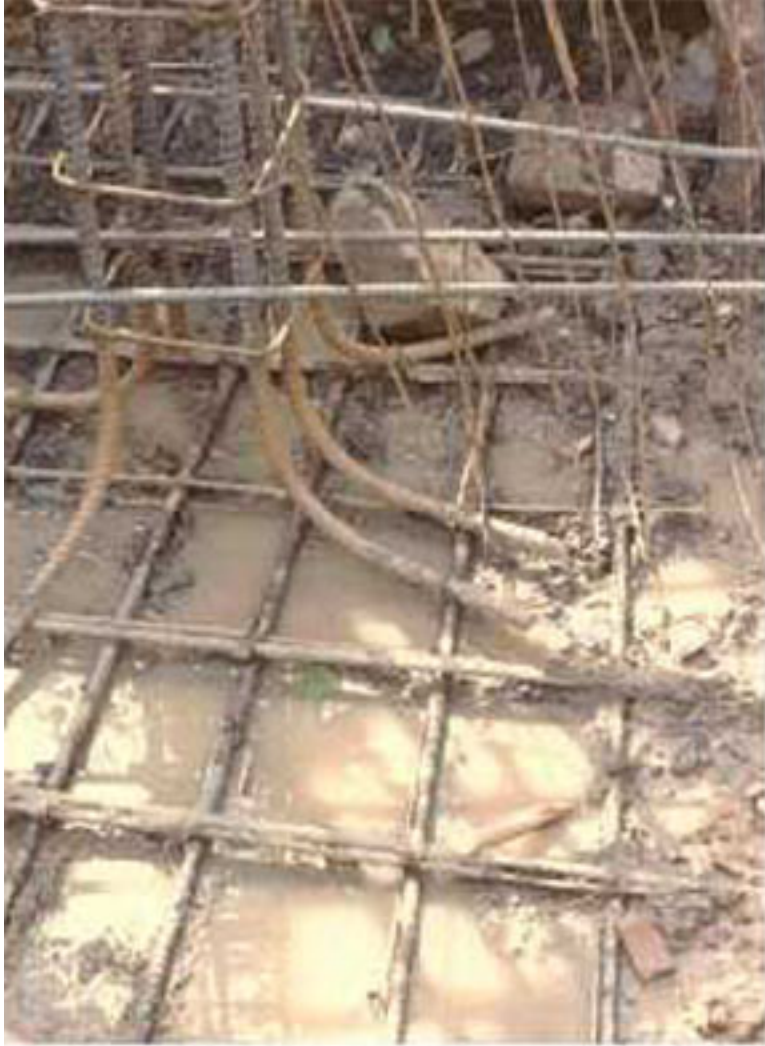
*FIGURE 5H: Poor Workmanship: Dirty groundwork and inappropriate column and bar anchorage*

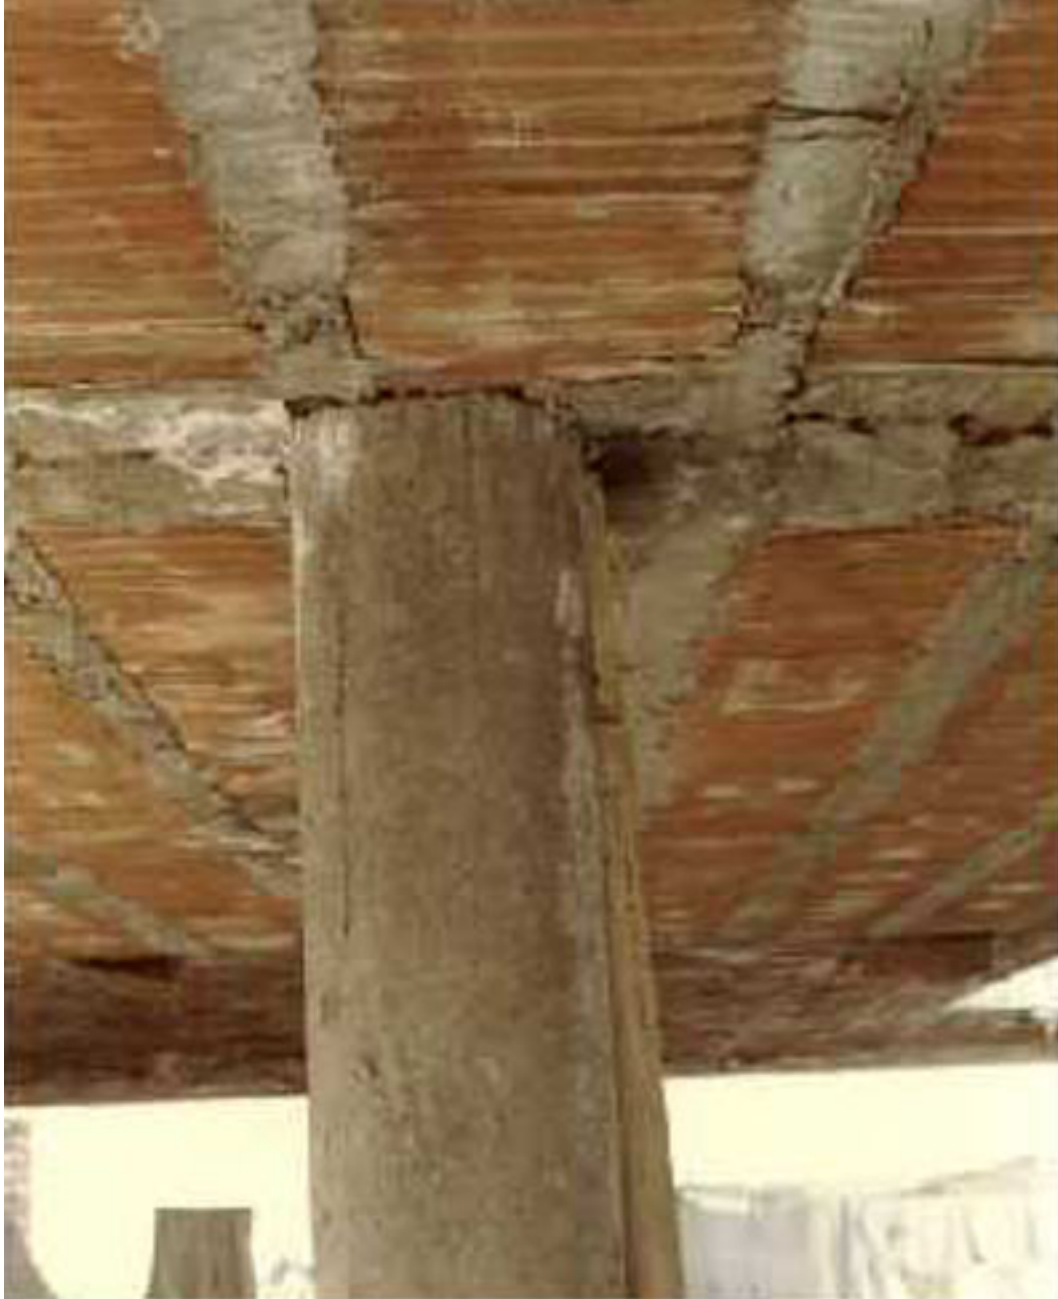
*FIGURE 5I: Poor Construction Practice: Drains running across the girders. Stirrups are removed to allow for the pipeline passage.*

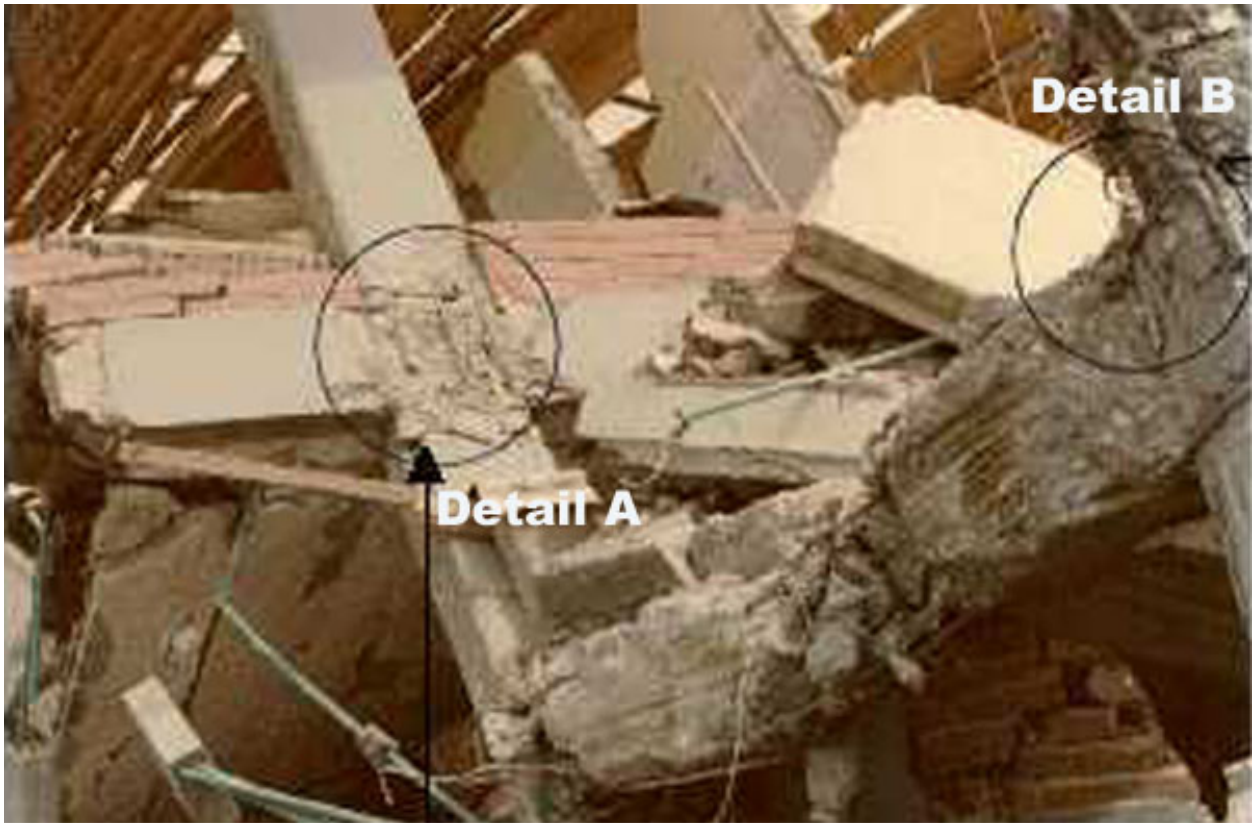
*FIGURE 6B: Earthquake Damage: Reinforcement splices in the joint zone (Detail A)*

*Additional Comments:* Most buildings of this type collapsed, killing the inhabitants, especially in the areas with pronounced soil amplification. Typical patterns of earthquake damage are illustrated in FIGURES 6A, 6B, 6C, 6D, and 6E. The figures confirm the importance of good construction practice and its impact on seismic performance.

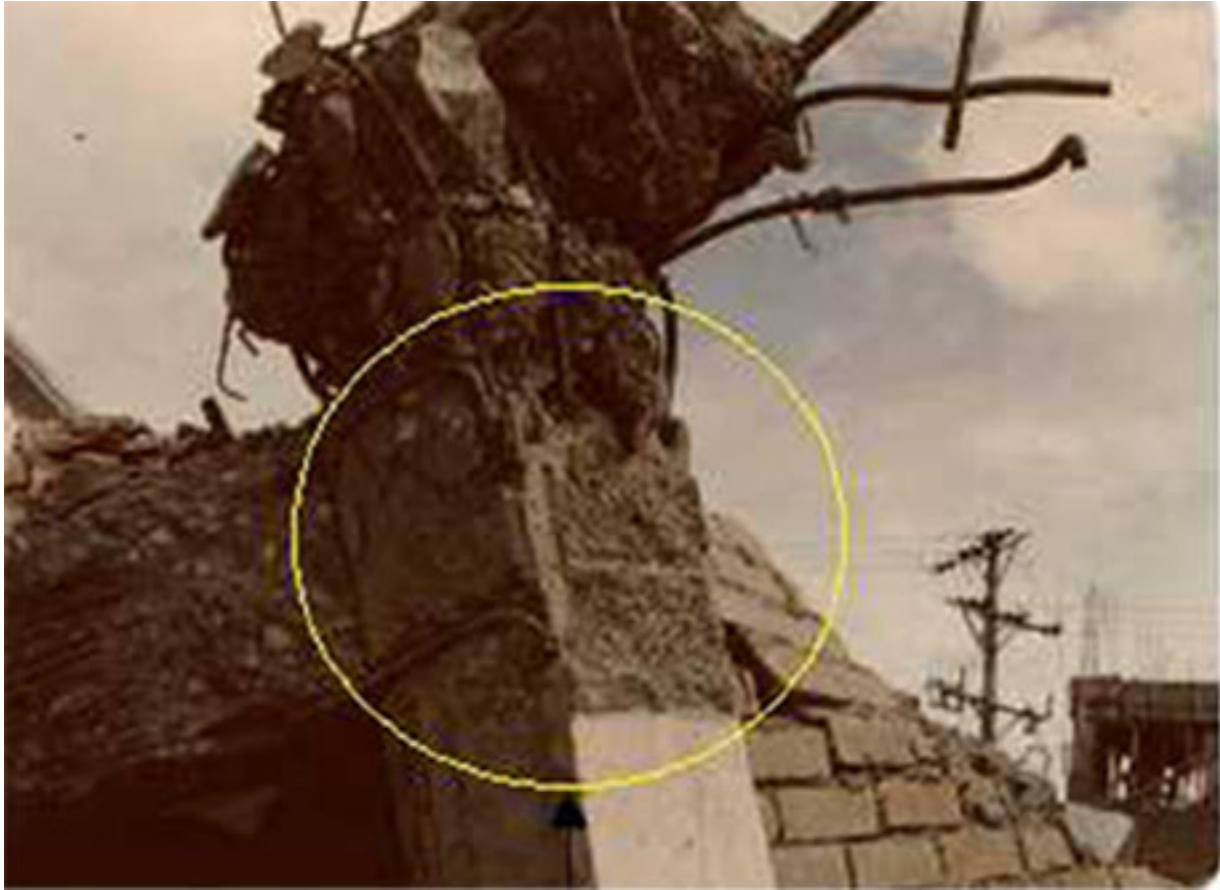
*FIGURE 6C: Earthquake Damage: Anchorage of beam reinforcement in the column cover area (It would be correct to anchor the reinforcement inside the joint.) Detail B*

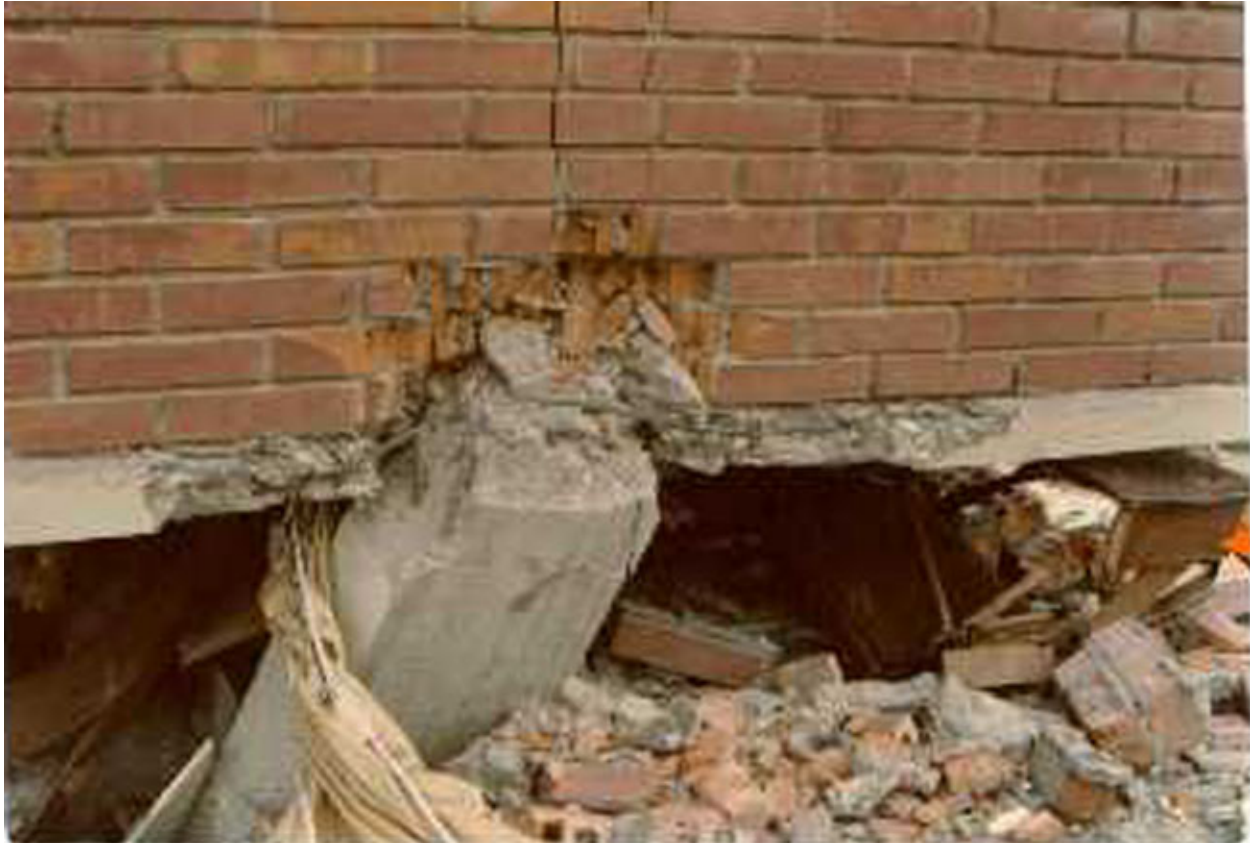
*FIGURE 6D: Earthquake Damage: Inadequate longitudinal and transverse reinforcement (Note the collapsed first story.)*

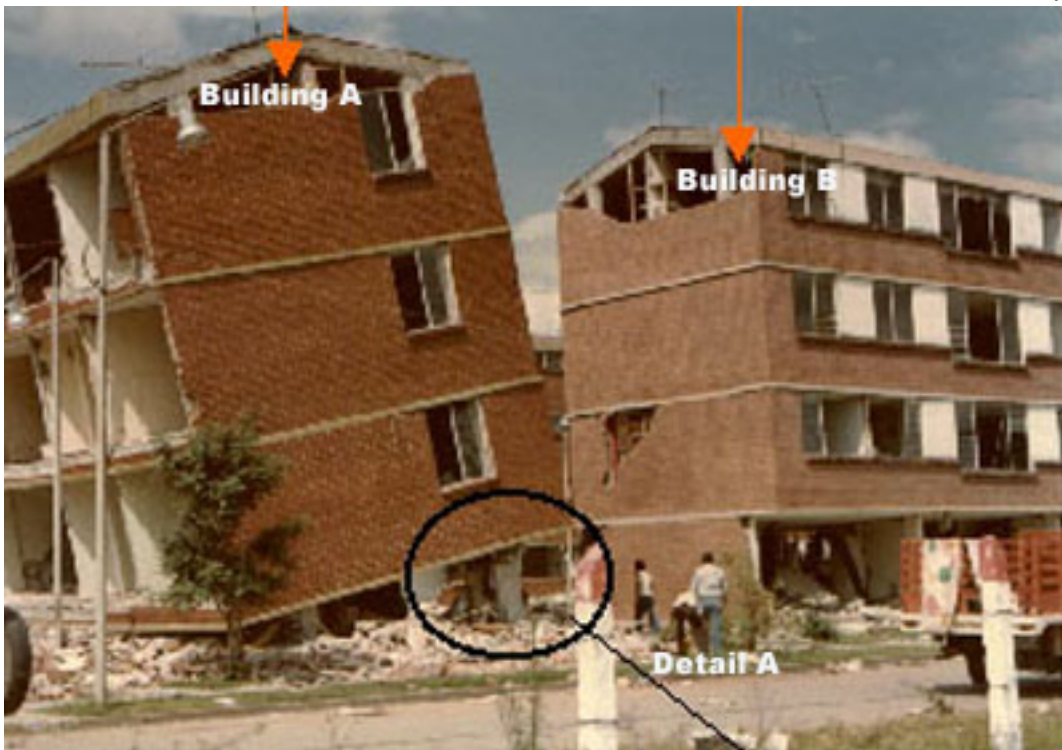
*FIGURE 6E: Collapsed building; Detail A shows too widely spaced stirrups*

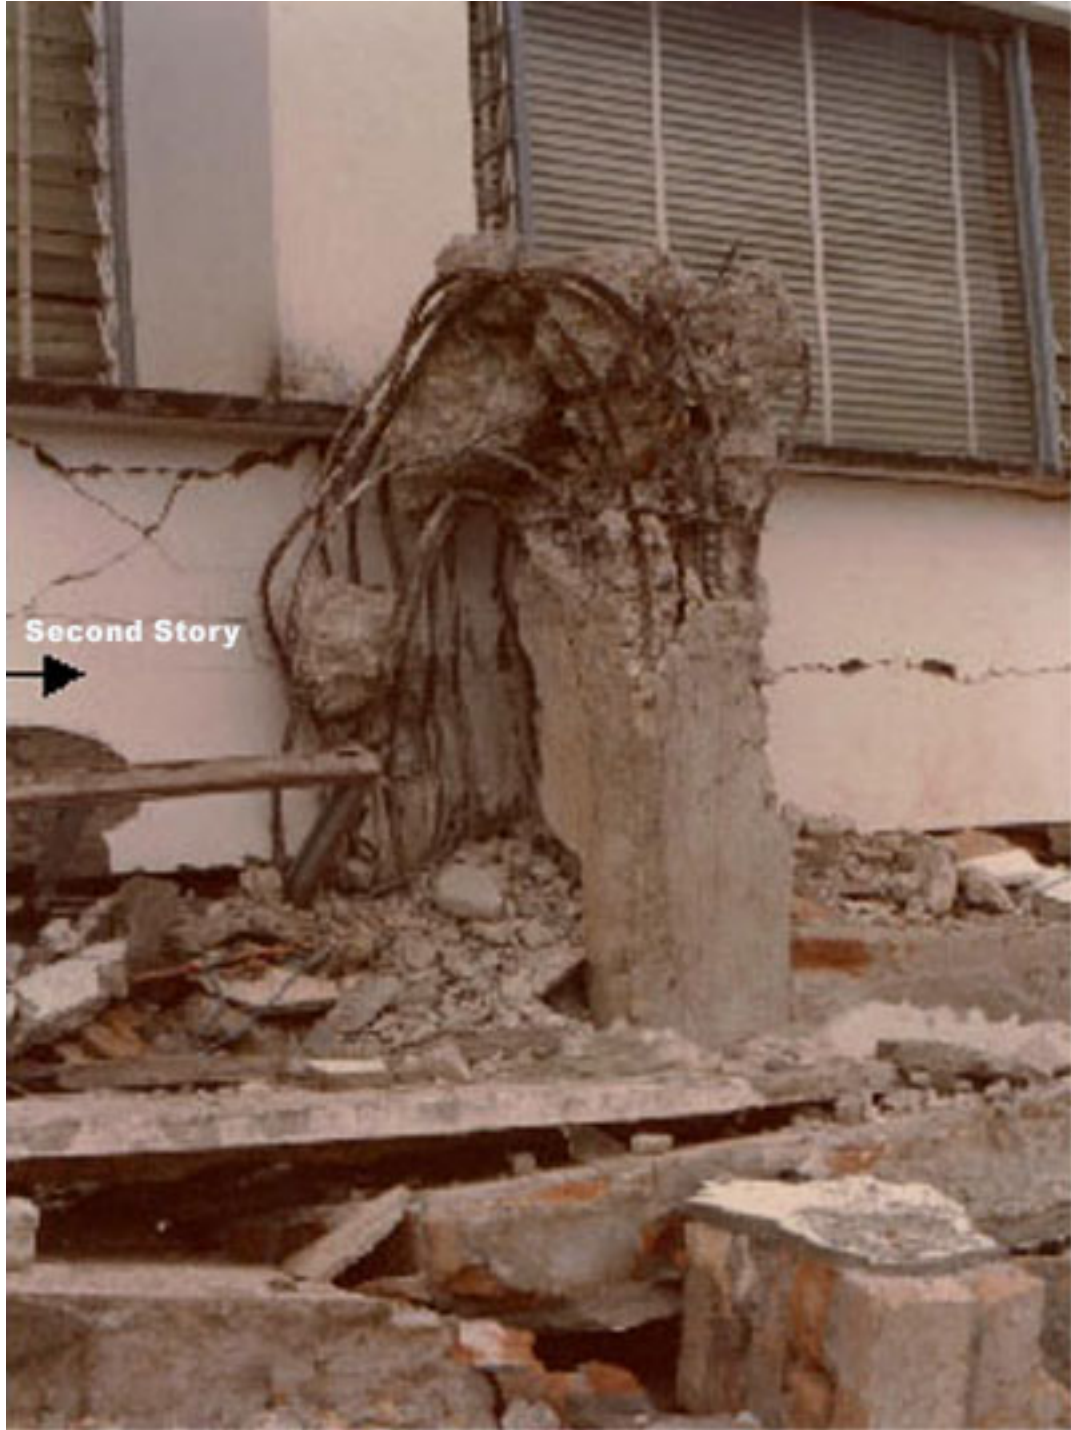
*FIGURE 6G: Collapsed 3-story building. (Note the total lateral drift between the 2nd and 3rd floor.)*

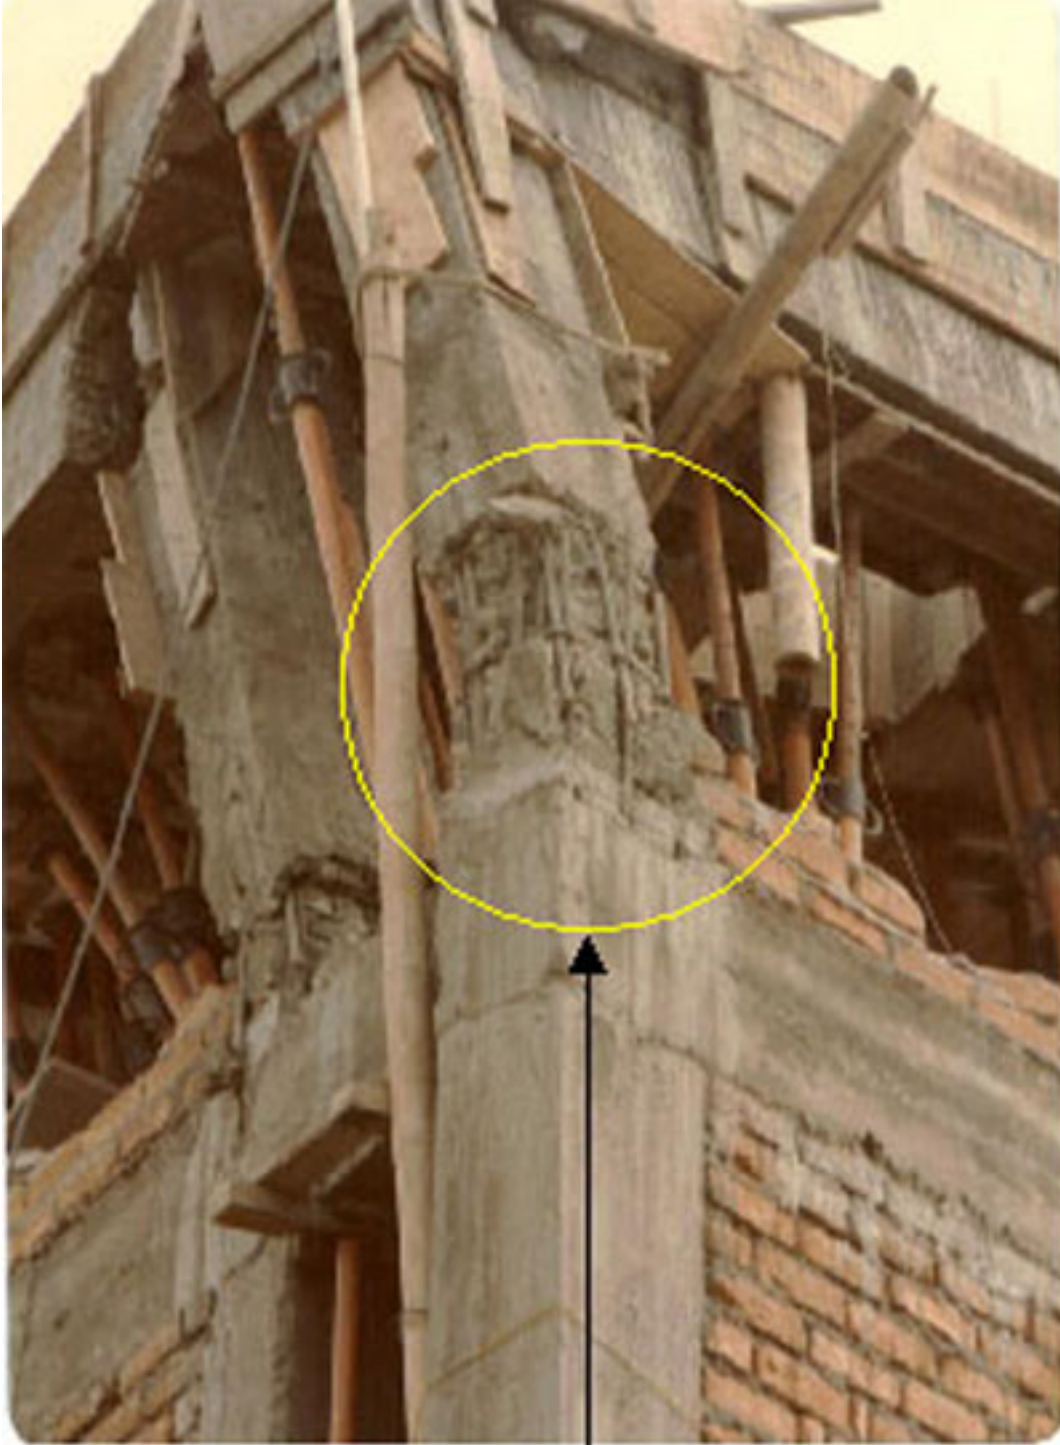
*FIGURE 6J: Earthquake Damage: Inadequate Column Splices*

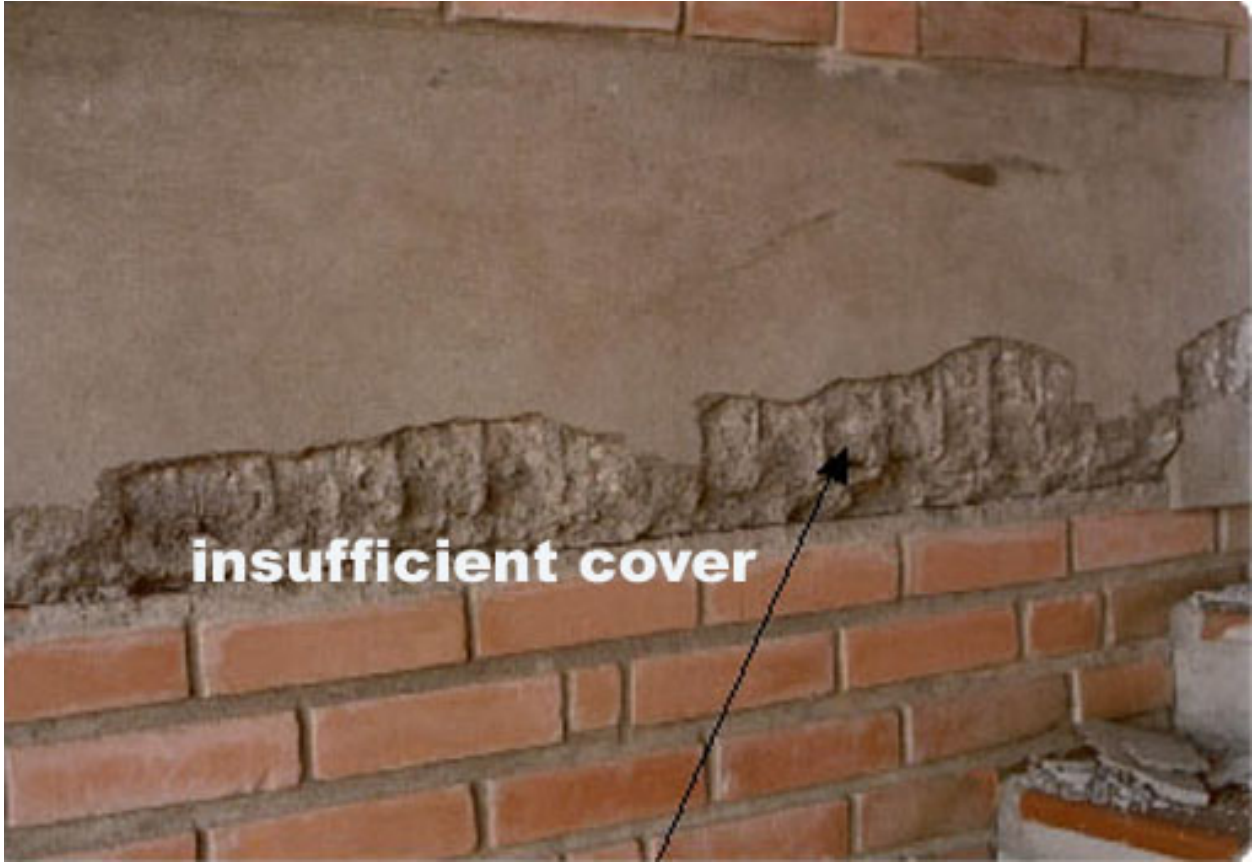
*FIGURE 6K: Earthquake Damage: Inadequate Concrete Cover*

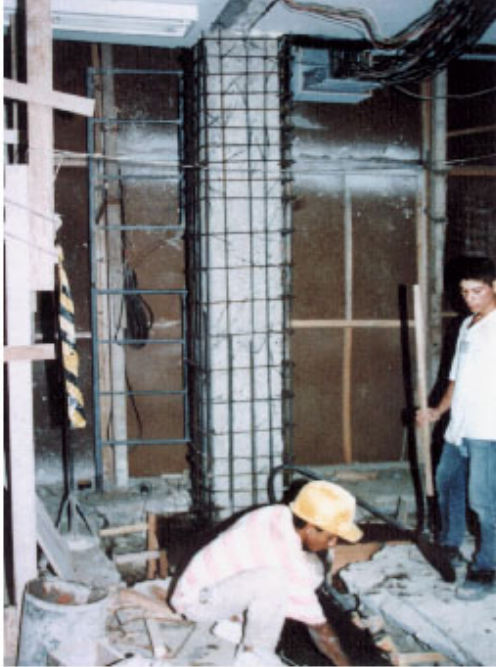
New added longitudinal and transversal reinforcement.

*FIGURE 7D: Seismic Strengthening Techniques: Field Implementation*

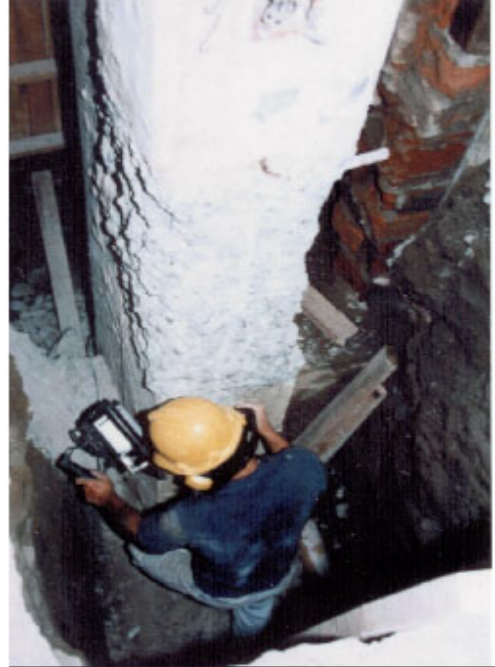
Anchorage of the new longitudinal reinforcement into the foundation

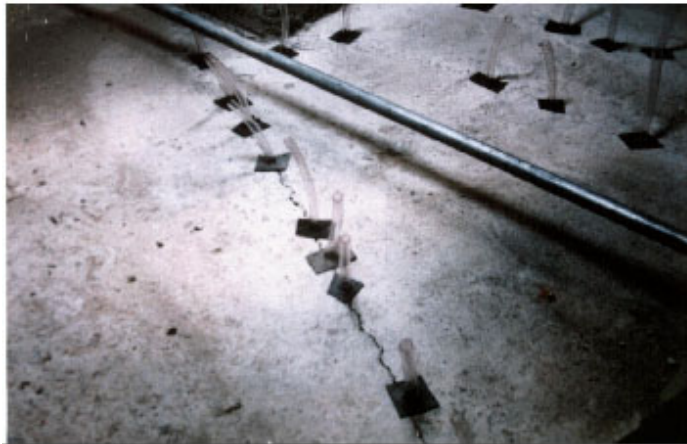
Epoxy injection of the cracks

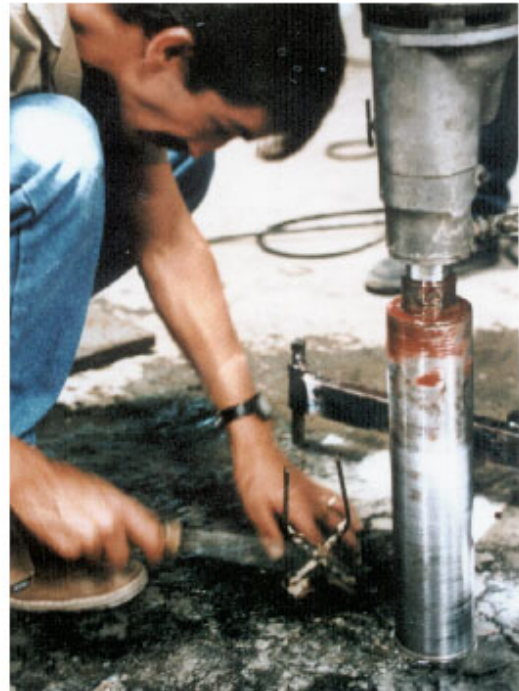
Extraction of concrete cores

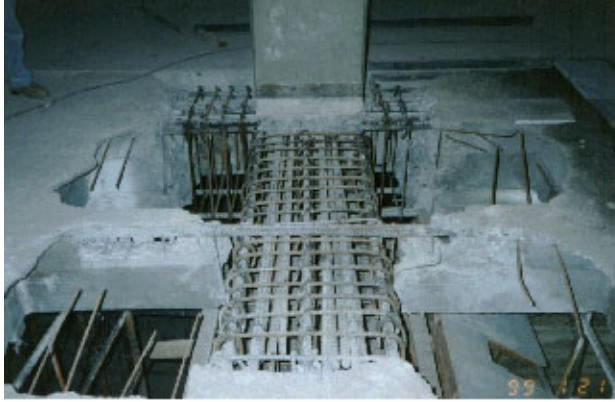
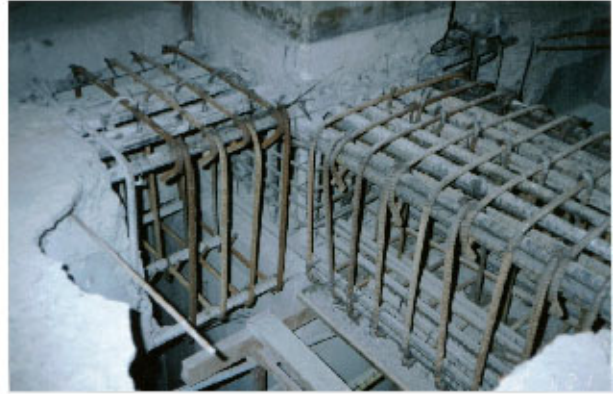
In some cases, new stirrups are installed to reinforce a beam-column joint. In this case, the existing concrete in the joint area must be carefully demolished.

*FIGURE 7E: Seismic Strengthening Techniques: Field Implementation*
